Project: Repair and Prolongation of Service Time of the Concrete Structures of the Pools in the “Zwembad Overbosch” in Den Haag (NL)

Subject: Application of CAST³⁺ conductive coating

Date: 14 August 2012

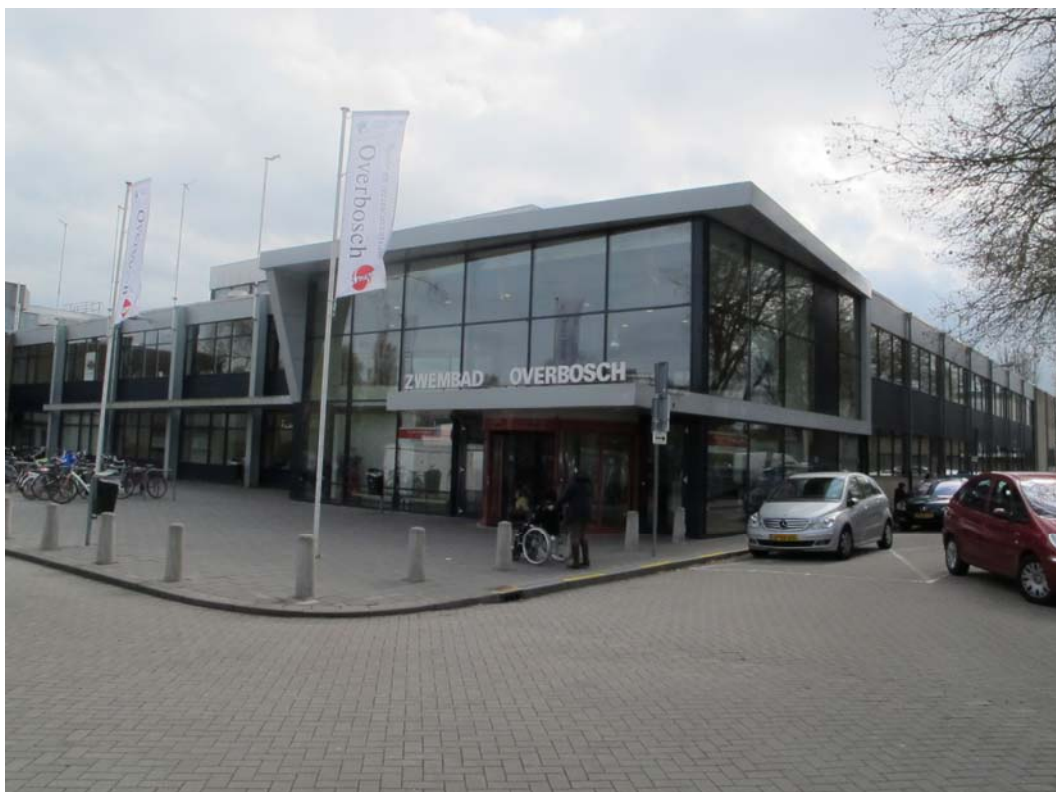
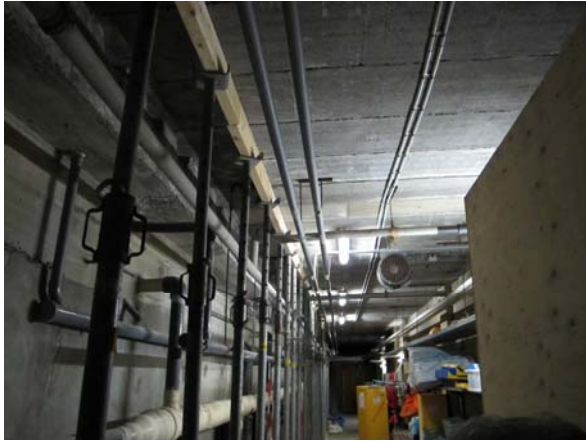
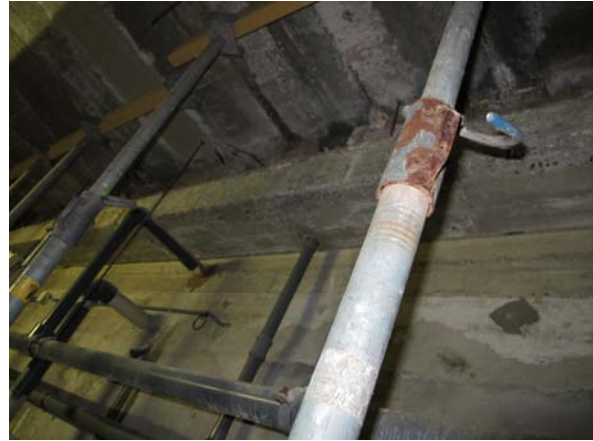
Concrete structure (overflow channels, concrete pool walls) of the Zwembad Overbosch in Den Haag.

The concrete structure of two pools in the “Zwembad Overbosch” in Den Haag (NL) was exposed over a prolonged time period to warm water loaded with calcium hypochlorite. The outside of the concrete of the overflow channels and of the concrete pool walls will be protected with the CAST³⁺ anode system.

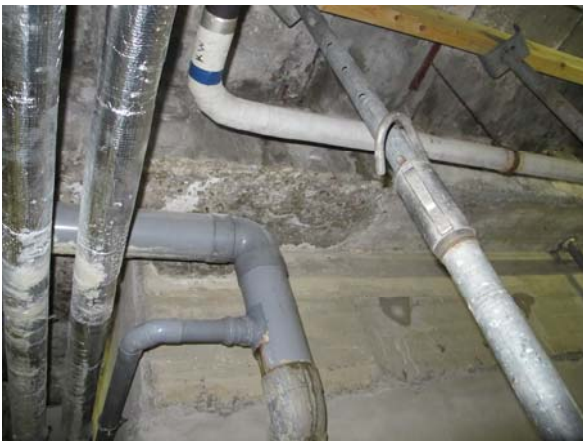
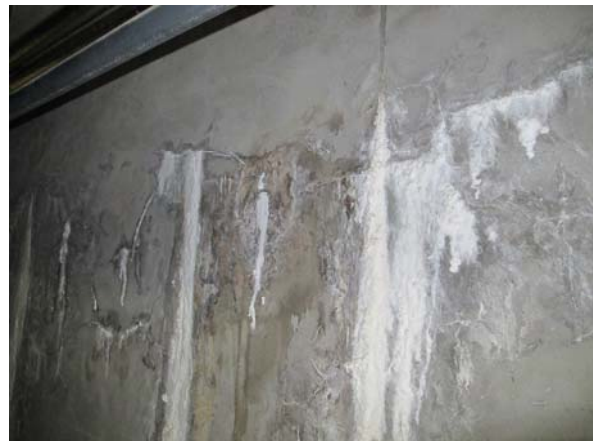
The damages to the concrete origins from the corrosion of the steel reinforcement in the concrete overflow channels and in the concrete pool walls due to the ingress of chloride and hypochlorite.

Visible damages to the concrete (cracks, effluorescence, steel corrosion products) due to ingress of water loaded with calcium hypochlorite into the concrete structure of the pools of the Zwembad Overbosch.

The steel reinforcement in the concrete overflow channels and the concrete pool walls will be protected from corrosion by applying CP with the CAST³⁺ conductive coating, forming the CAST³⁺ Composite Anode.

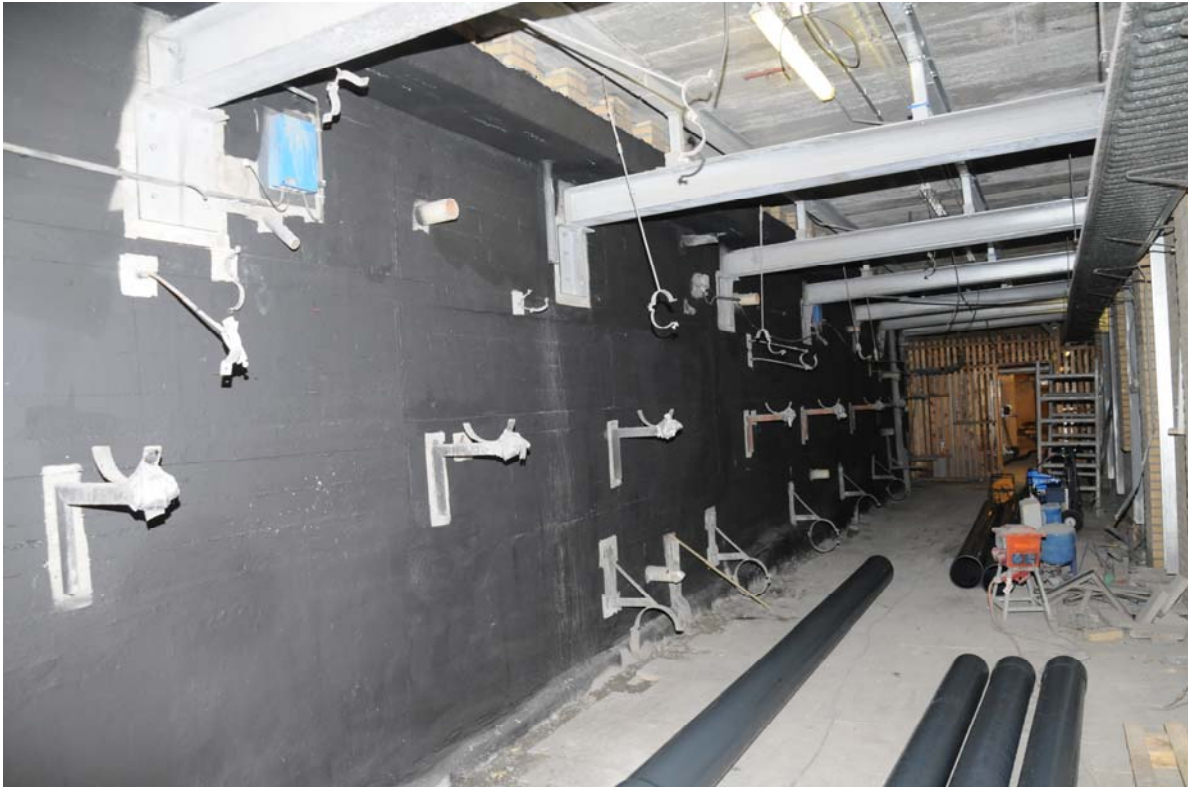
CAST³⁺ Composite Anode installed on the outside walls of one of the swimming pools - overview

The CP systems were installed in July/August 2012, the CAST³⁺ composite anode system on the outside walls and bottom of the pools:

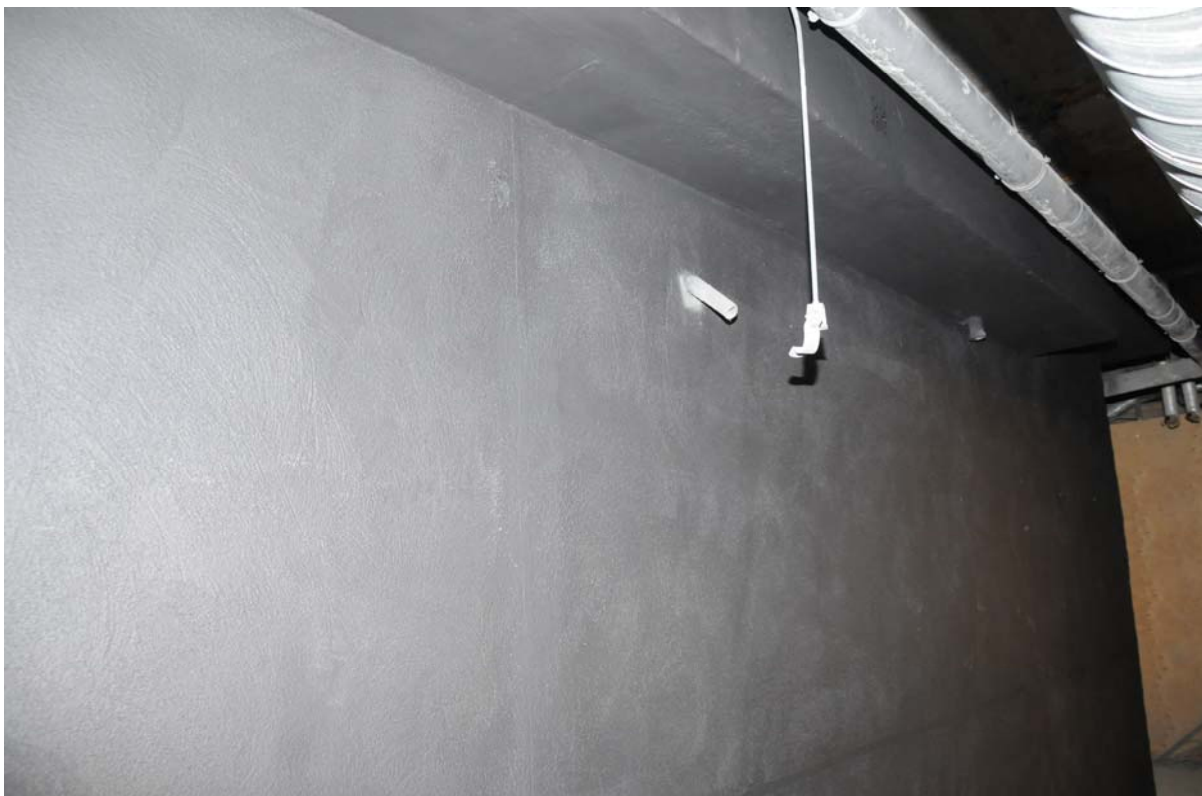
CAST³⁺ Composite Anode installed on the outside walls of one of the swimming pools - close up view

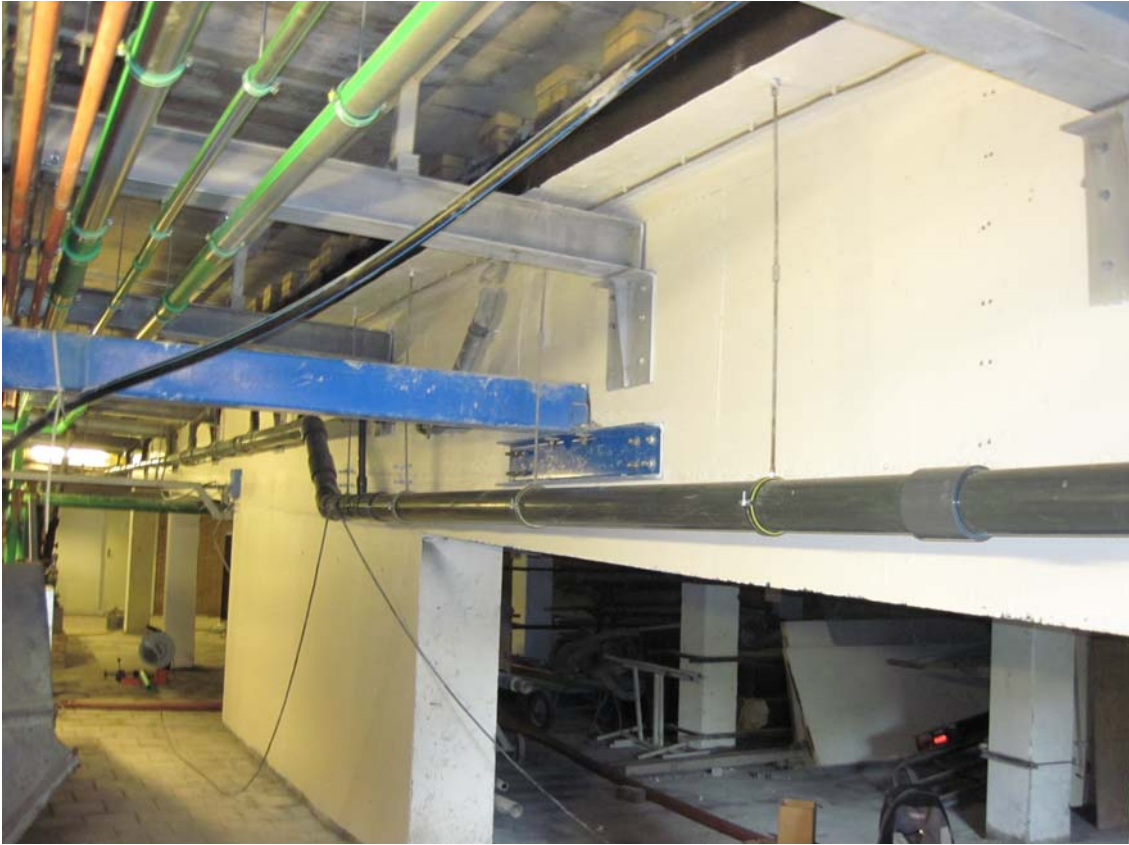
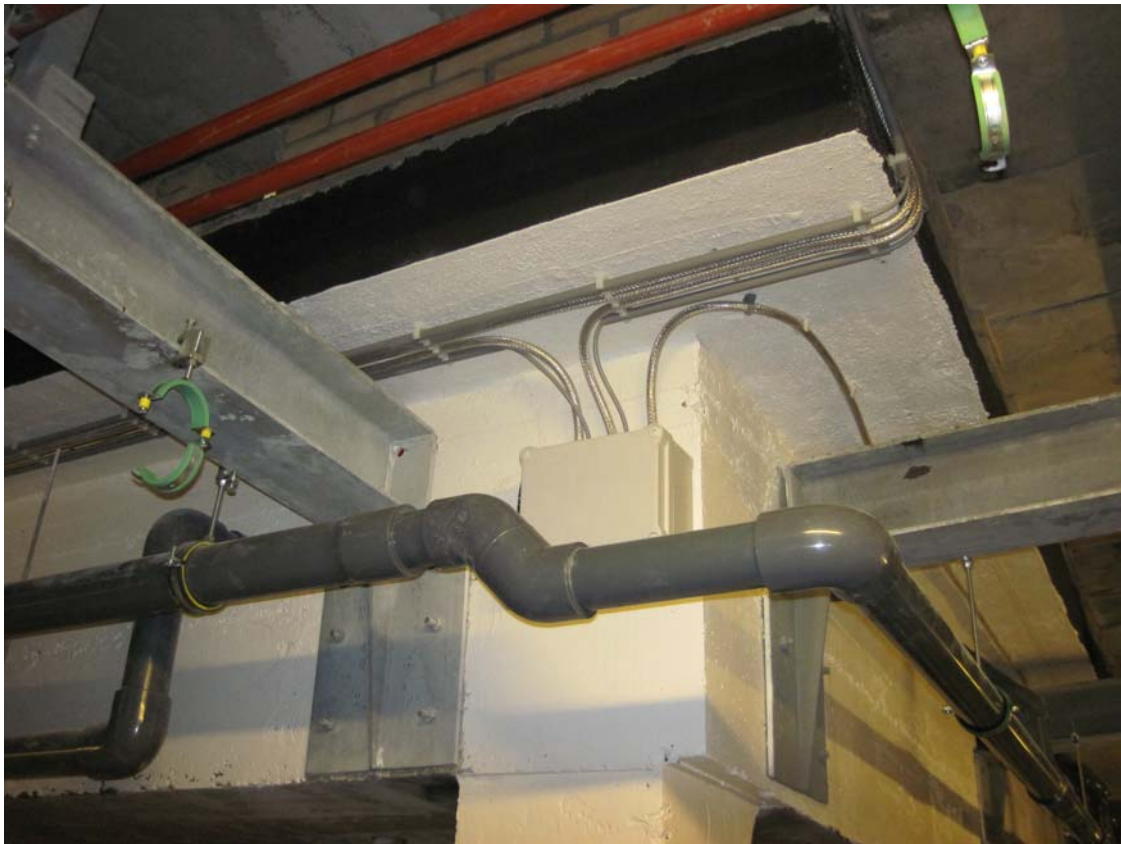
Acrylic cover coating (Sikkens Alphatex IQ) on the CAST³⁺ Composite Anode installed on the outside walls of the swimming pools
