3<sup>rd</sup> International Conference on Concrete Repair, Rehabilitation  
and Retrofitting Repair, September 3–5, 2012, Cape Town,  
South Africa

**Repair of Concrete Members of Seaside Apartment  
Buildings Deteriorated by Steel Corrosion**

W. Schwarz, F. Müllner

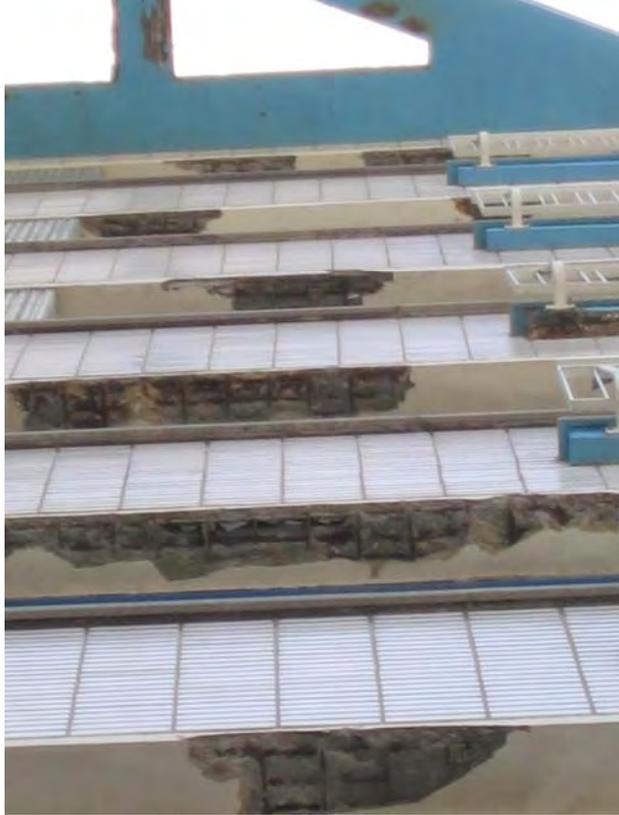
Figure 1: Spalling and disbondment of the concrete cover due to steel rebar corrosion.

Examples for typical damages, induced by the corrosion of the steel reinforcement, are shown in figures 1 & 2. Typical types of damages are spalling and disbondment of the concrete cover (figure 1), degradation of edge beams and spalling and degradation of supporting beams (figure 2). Depending on the time of exposure and degree of contamination, significant loss of cross section of the steel reinforcement is observed that may lead to structural failure of the concrete members.

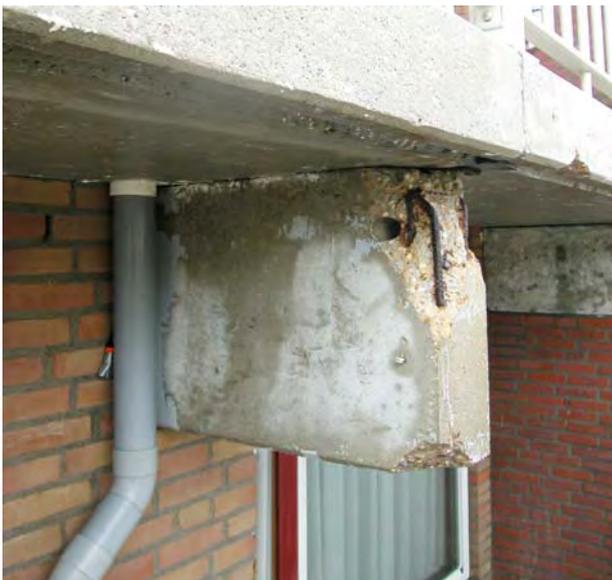
Figure 2: Spalling and local destruction of the concrete cover of supporting beams, severe loss of cross section of steel rebars due to steel rebar corrosion.

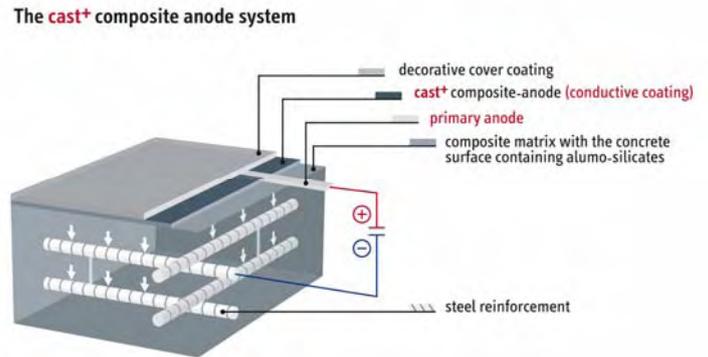
Figure 4: Schematic presentation of the CAST<sup>+</sup> composite anode system, based on the CAST<sup>+</sup> composite anode paint.

The composite paint is applied like any other concrete paint either by rolling or by air-less spray. Current distributors – termed as primary anodes – are embedded into the composite paint (figure 4). Finally, a decorative cover paint is applied. Most of the available acrylic paints but also epoxy or polyurethane paints or coatings are suitable as decorative top coats. If high current densities are required, cover coats with high water vapour permeability are recommended.

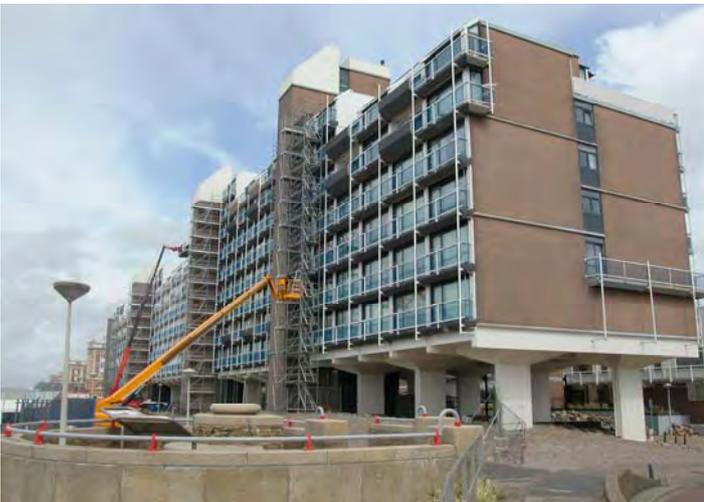
Figure 5: Installation of the CAST<sup>+</sup> composite anode system on apartment buildings in Scheveningen 2008.

Scheveningen, a district of Den Hague – the capital of the Netherlands - is a modern and a prominent beach resort in the Netherlands. Overlooking the beach, close to the famous pier and the Kurhaus concrete elements of the façade of an apartment complex were repaired and protected with the composite anode system covering a total area of 1600 m<sup>2</sup> (figure 5).

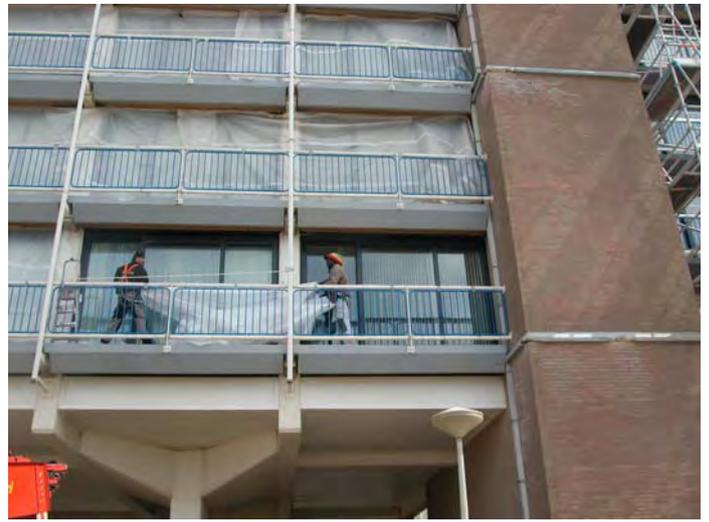
Figure 6: Covering the windows with plastic sheets before repair and installation works start.

Before concrete repair and installation works start, windows are covered and protected with plastic sheets (figure 6). The concrete surface was cleaned and prepared for the CAST<sup>+</sup> composite anode system with high pressure (500 atm) water jetting (figure 7).

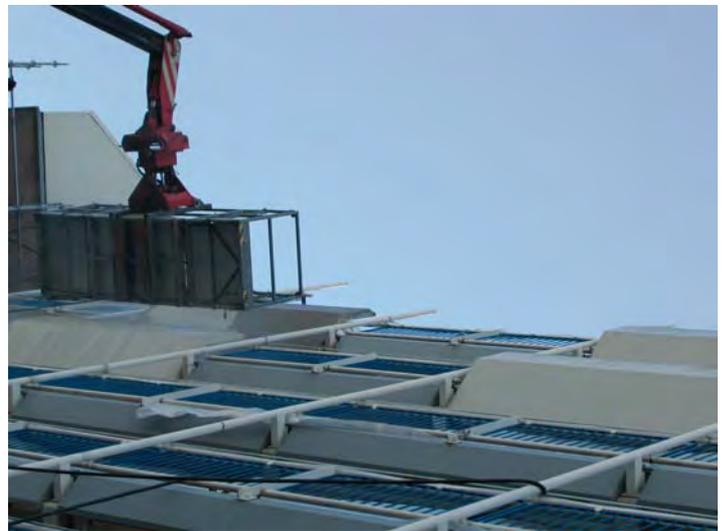
Figure 7: Cleaning of the concrete surface by high pressure water jetting.

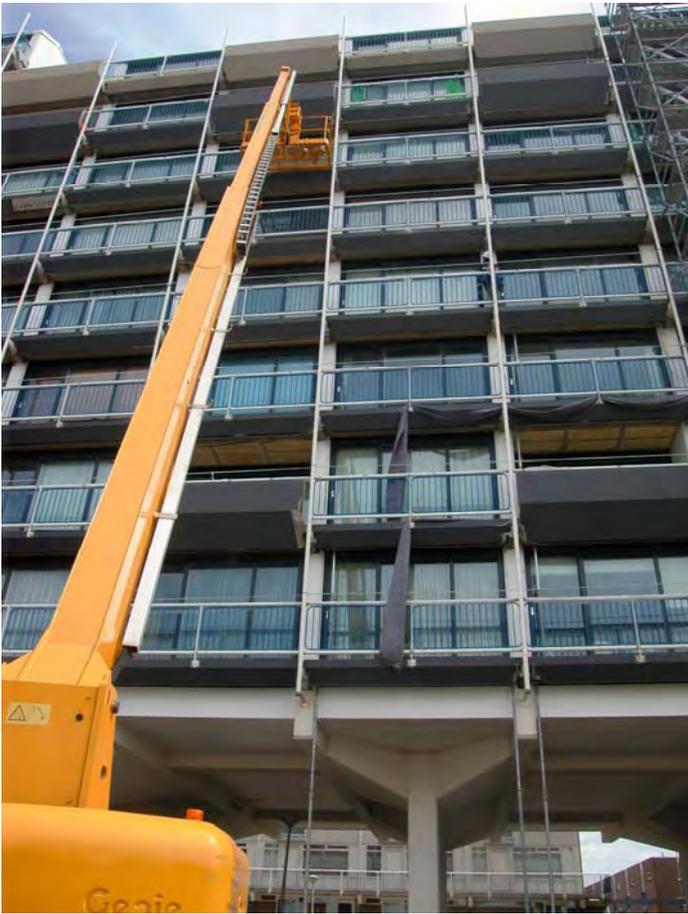
Figure 8: Application of the CAST+ composite paint on balconies, roof decks and balustrades (paint with anthracite colour).

After cleaning the concrete surface, installation of sensors for remote monitoring the efficiency of the corrosion protection of the steel reinforcement, removal of binding wires and covering of potential short circuits with epoxy coatings, the CAST<sup>+</sup> composite paint is applied (figure 8).

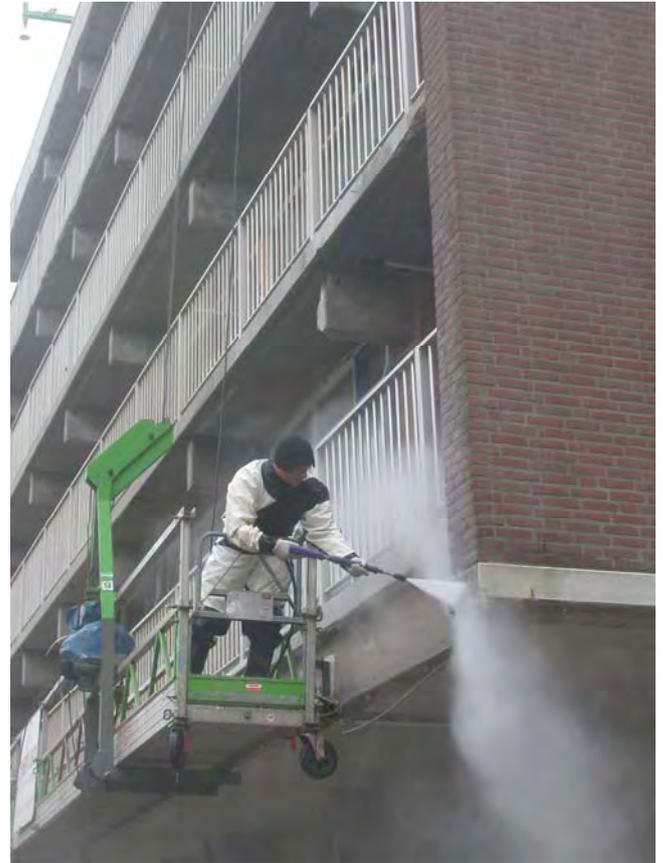
Figure 10: Concrete surface preparation and cleaning by high pressure water jetting.

In 2005, apartment blocks near the center of Scheveningen were repaired and protected with the CAST+ composite anode system. The CAST+ system was applied on balconies, supporting beams, balustrades with a total surface of 450 m<sup>2</sup>. Before applying the composite anode system, the concrete surface was cleaned by water jetting with 400 bars (figure 10).

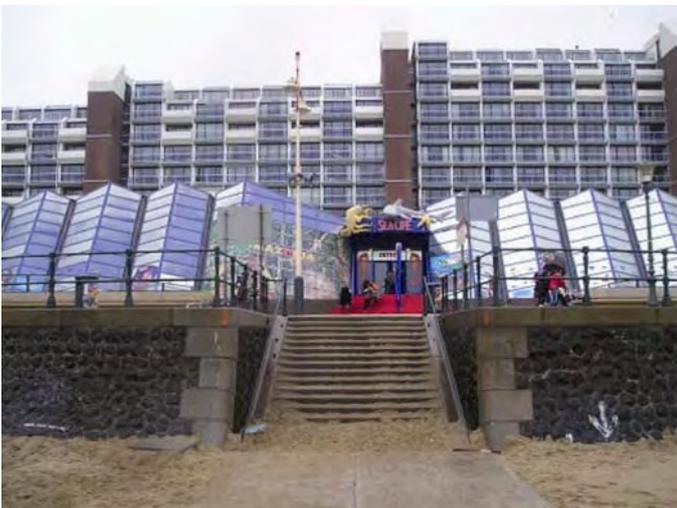
Figure 9: Apartment building in Scheveningen Strand after completion of repair works.

After application of the CAST<sup>+</sup> system, installation of the current distributors (termed as primary anodes) and after completion of electrical installation works (wiring, distributors, central control and data-logging unit), a cover coat is applied (figure 9).

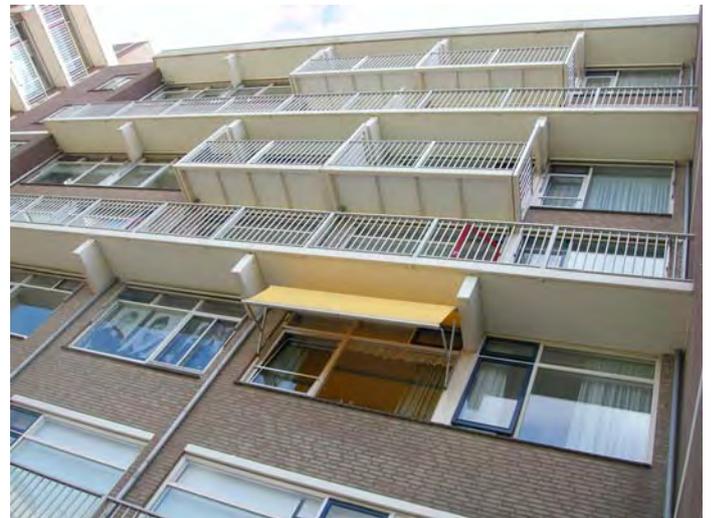
Figure 11: View on the apartment building after application of the CAST+ system and after application of white acrylic cover coating.

The concrete surface In figure 11, part of the apartment building is shown after completion of repair and installations works.

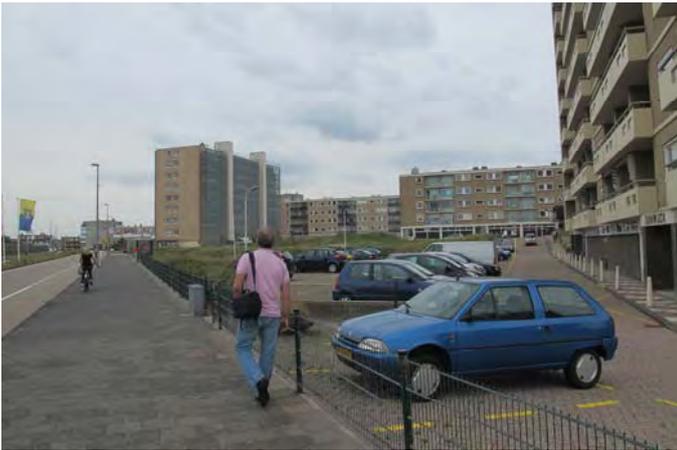
Figure 12: Apartment block (left side, with scaffolding) in Zandvoort, repaired and protected with the CAST<sup>3+</sup> composite anode system.

One of the apartment blocks repaired and protected with the CAST<sup>3+</sup> composite anode system is shown in figure 12.

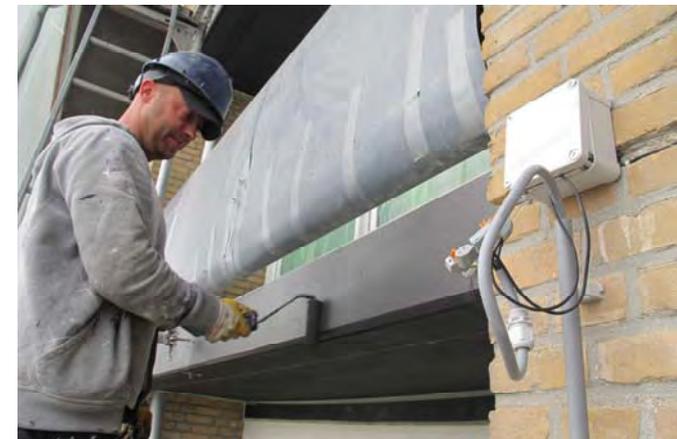
Figure 13: Balustrades and underside of balcony, coated with the CAST<sup>3+</sup> composite anode paint.

The underside of balconies, balustrades and beams were coated with the CAST<sup>3+</sup> composite anode paint as shown in figure 13 & 14. After installation of the current distributors (termed as primary anodes), a white cover paint, top coat from Sikken, was applied (figure 15).

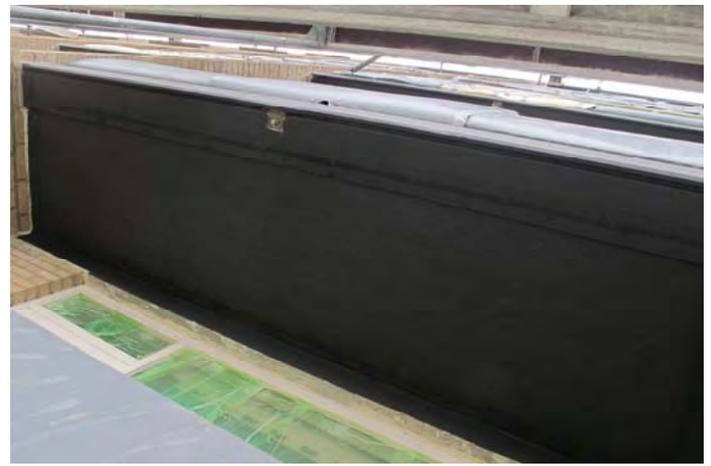
Figure 14: Underside of balcony coated with the CAST<sup>3+</sup> composite anode paint.

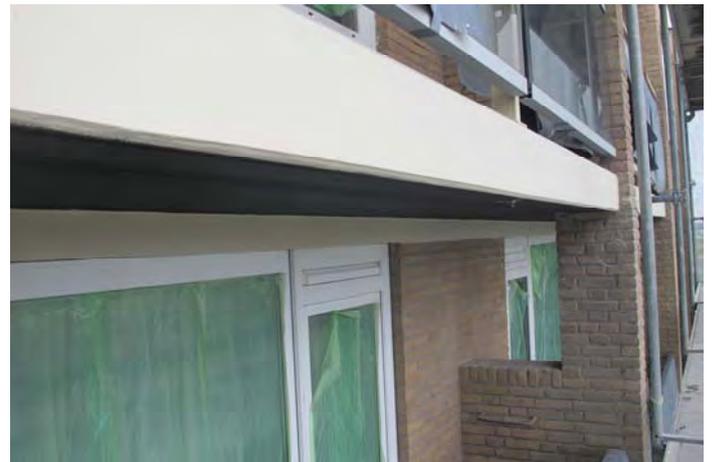
Figure 15: Application of a white top coat after the installation of the CAST<sup>3+</sup> system.
