**Project:** Galvanic Corrosion Protection „Alplgraben Bridge“  
**Date:** 25. September 2012  
**Author:** W. Schwarz

In the scope of a research project, the embedded zinc anode (EZA) was installed in September 2007 on concrete members especially endangered by steel reinforcement corrosion (bridge deck & cantilever underside, abutment) of the Alplgraben bridge in the Styrian Alps and put into operation on 1 November 2007. Operational data and performance were presented at the 4th International Conference on Concrete Repair – “Concrete Solutions”, Dresden, Germany, 26 – 28 September 2011 and on the 3rd International Conference on Concrete Repair, Rehabilitation and Retrofitting, Cape Town, South Africa, 3 – 5 September 2012. The data proved that the steel reinforcement was reliably protected from corrosion by the EZA system.

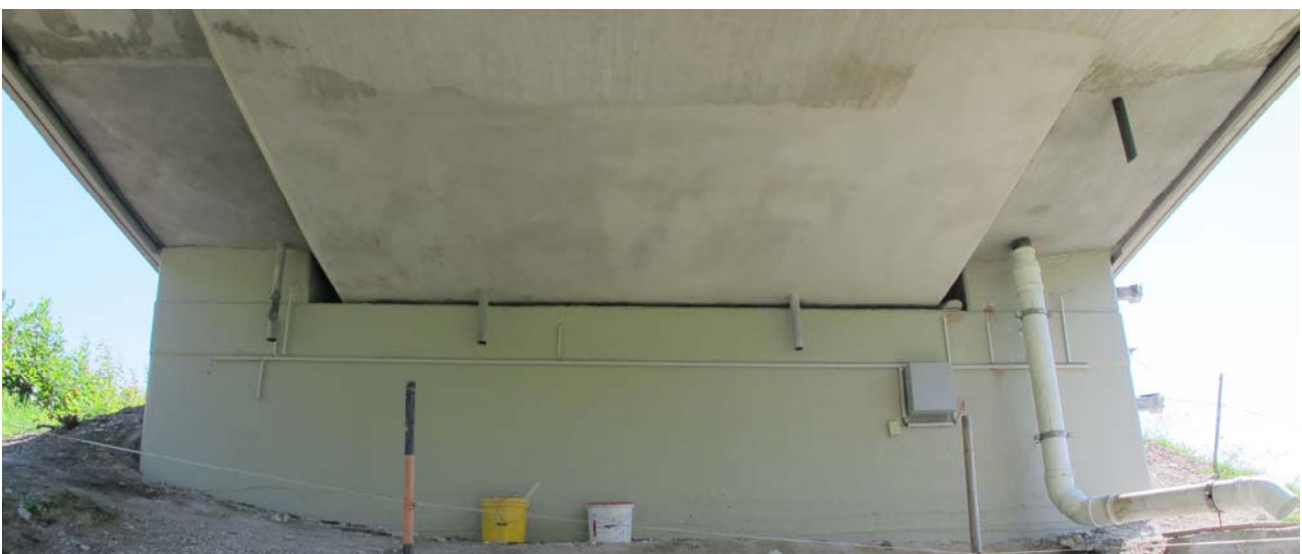
On an about 30 cm wide strip below a leaking joint, the EZA has been frequently exposed to de-icing salt solution. The embedded zinc was consumed to a large extent (up to 75%). In that area, a new zinc mesh was applied on top of the existing EZA.

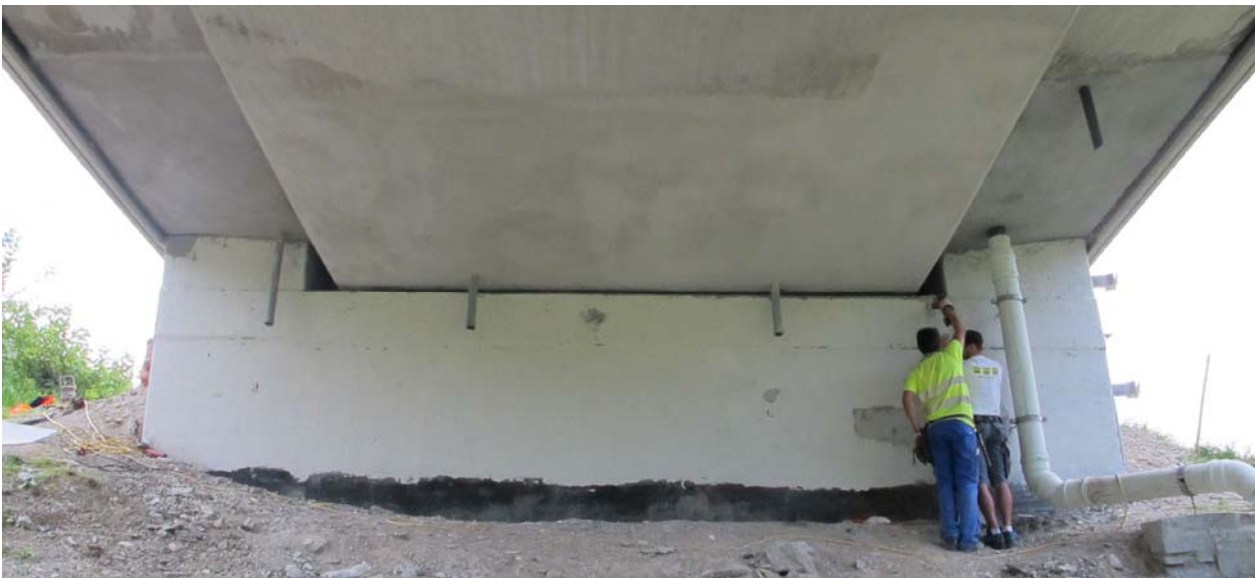
EZA on the abutment of the Alplgraben bridge after sand blasting (21 August 2012)

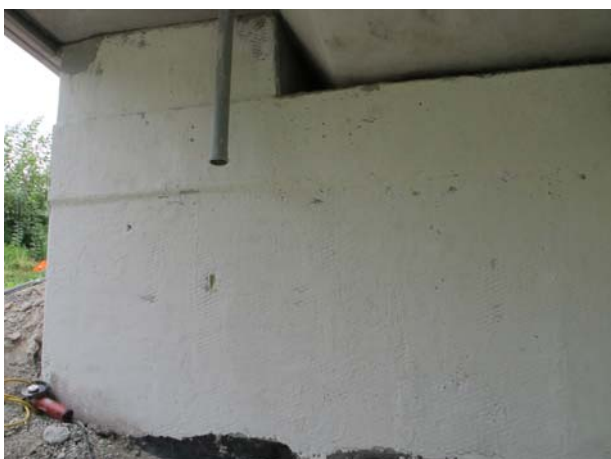
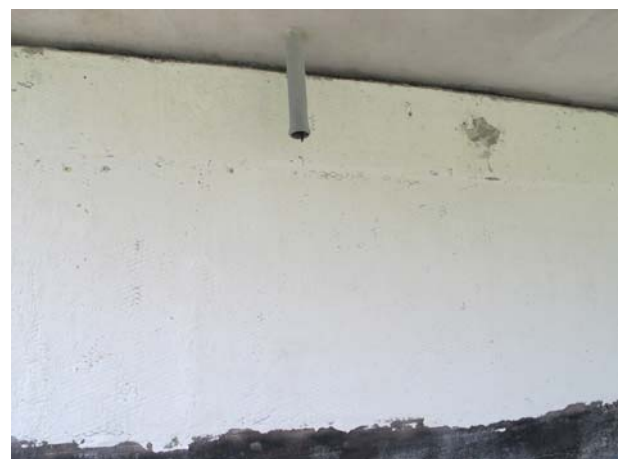
Detail after sandblasting: abutment hillside (left), middle part of abutment (right)

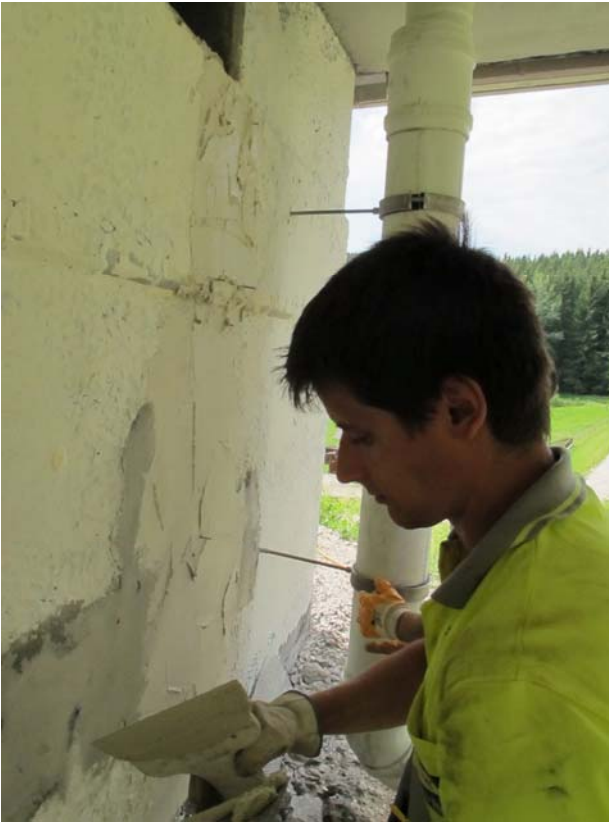
Application of the EZA binder before applying the zinc mesh

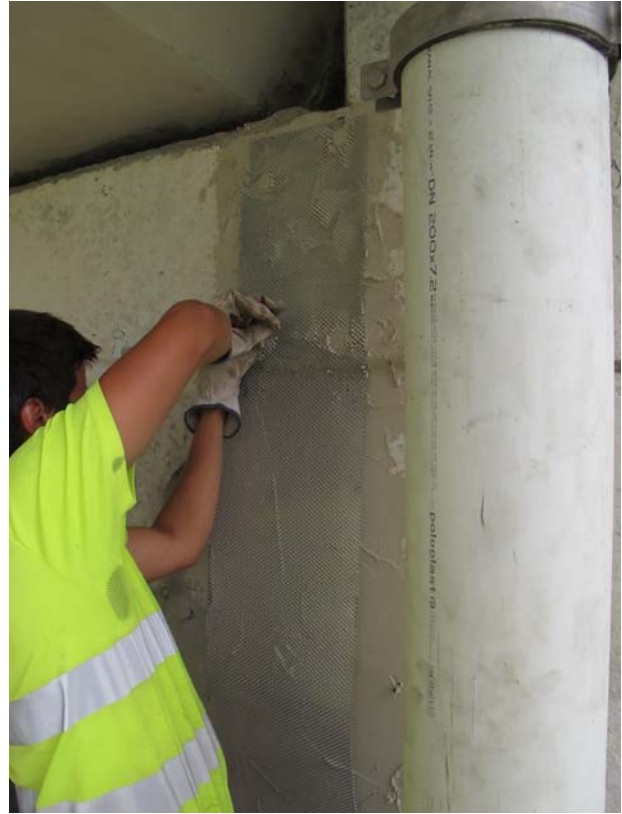
Application of the new zinc mesh and fixation with dowel pins

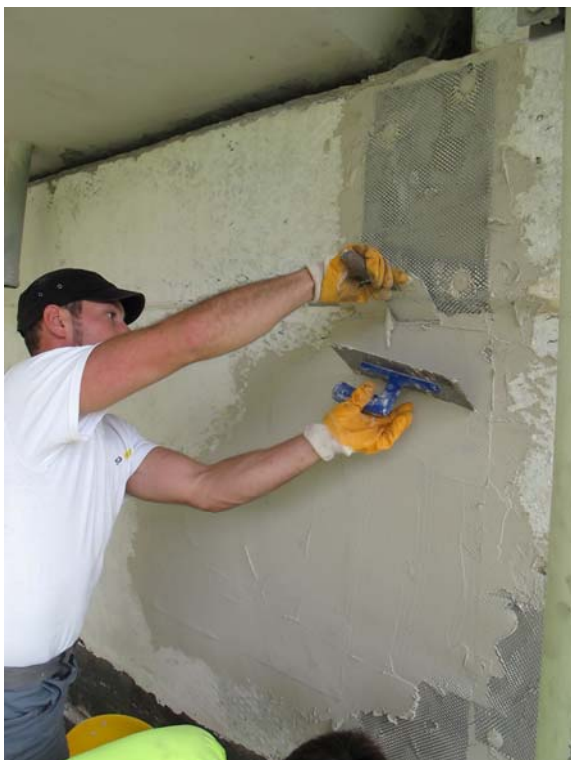
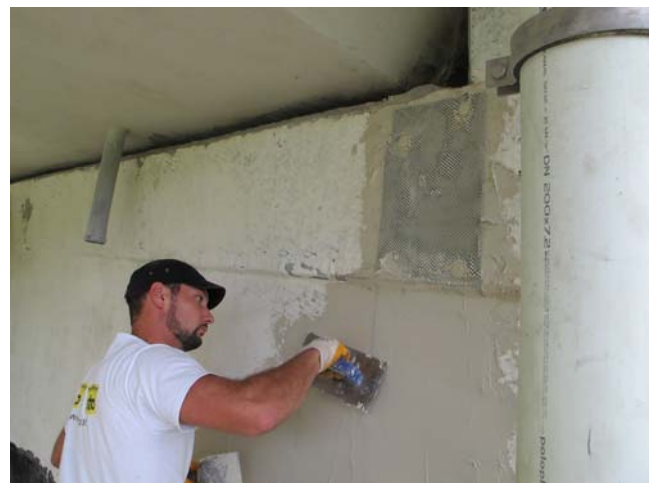
Embedding the zinc mesh with the EZA binder

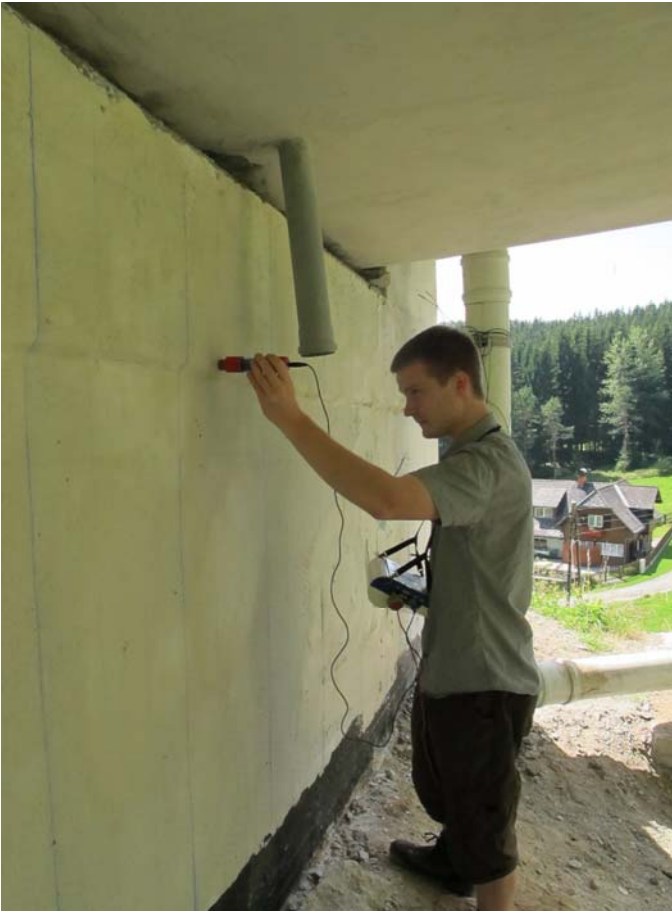
Potential field measurements with a  $\text{Cu}/\text{CuSO}_4$  electrode (Canin – PROCEQ) – 25. 8. 2012 by coworkers of the Institute of Structural Engineering of Prof. Konrad Bergmeister, University of Natural Resources and Life Sciences, Vienna

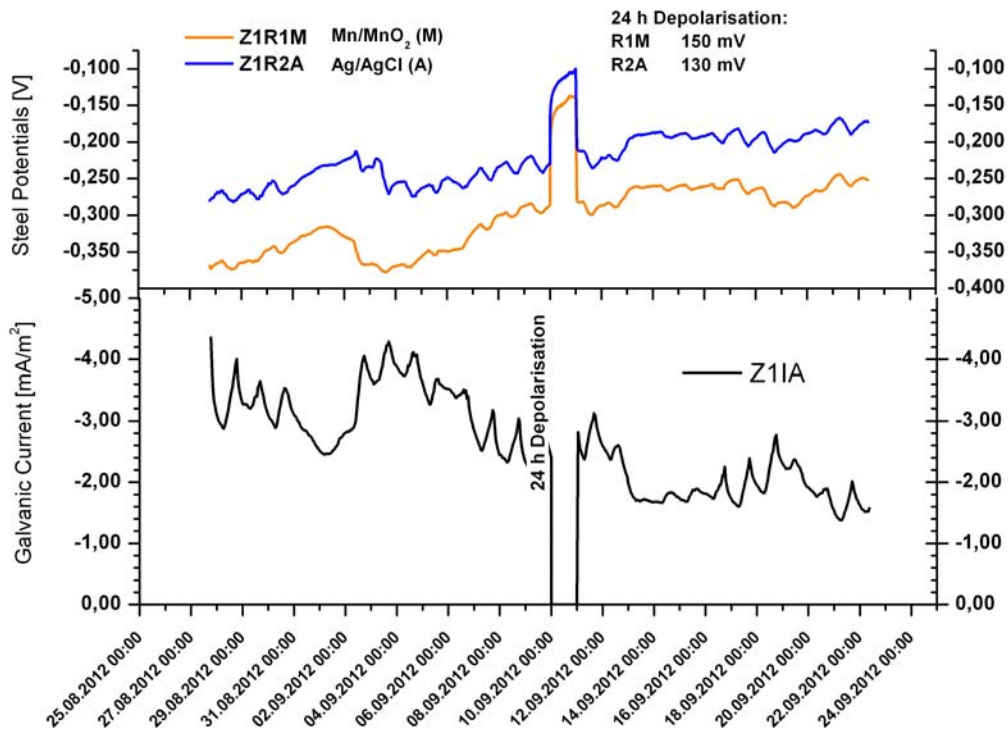
Steel potentials, measured against Ag/AgCl and Mn/MnO<sub>2</sub> reference cells, in relation to the galvanic current

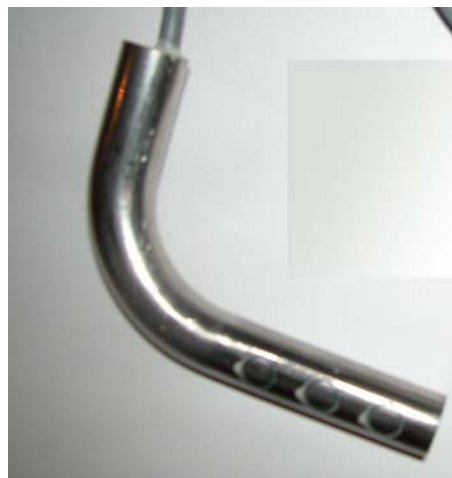
The effectiveness of the galvanic protection by the EZA may be controlled in real time by the embedded macro-cell sensors. The macro-cell sensor set embedded into the concrete overlay is shown in the figure below. It consists of 3 macro-cell sensors with a surface of 1 cm<sup>2</sup> each, placed in the supporting tube at a distance of 2 cm from each other. The macro-cell sensors were embedded into the concrete overlay with an anchor mortar containing 1,5% Cl/weight dry mortar. The thickness of the embedding mortar was about 1 mm. To monitor the efficiency of the EZA, the upper two sensors, placed 1 cm and 3 cm from the concrete surface, are monitored.

*Macro-cell sensor set: 3 sensors placed in a distance of 2 cm from each other with a surface of 1 cm<sup>2</sup>.*

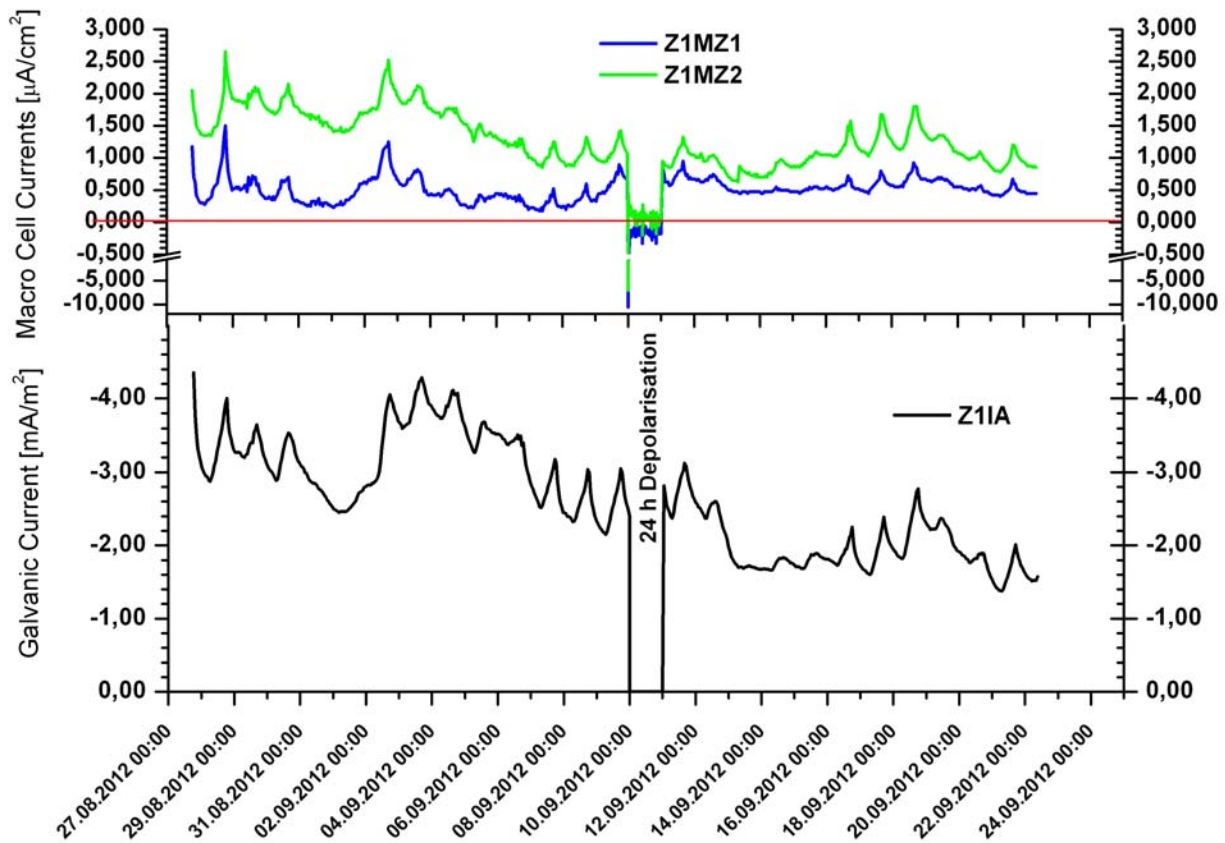
During the operation of the EZA, a cathodic current in the range of 0,5 – 2,5  $\mu\text{A}/\text{cm}^2$  flows to the macro-cell sensors MZ1 and MZ2, corresponding to a galvanic current of 5 – 25 mA/m<sup>2</sup>. During the 24 hour depolarisation measurement, a corrosion current of 0,15 – 0,20  $\mu\text{A}/\text{cm}^2$  from the macro-cell sensor MZ1 to the steel reinforcement whereas the macro-cell sensor MZ2 remains in the passive domain with a macro-cell current in the range of – 0,050 bis + 0,050  $\mu\text{A}/\text{cm}^2$ .

Macro-cell currents measured during the galvanic protection of the steel reinforcement by the EZA and during the 24 hour depolarisation measurement according to ISO ON EN 12696
