MAINTENANCE AND REPAIR OF STEEL REINFORCED CONCRETE STRUCTURES BY SIMULTANEOUS GALVANIC CORROSION PROTECTION AND CHLORIDE EXTRACTION

ABSTRACT: A novel galvanic zinc anode system, composed of a zinc mesh embedded into a proprietary binder that solidifies into a solid matrix with ion exchange properties, was developed by CAS. The solid matrix of the embedded zinc anode system (EZA) is based on a tecto-alumosilicate-binder containing additives that prevent passivation of the zinc anode, assure high and durable galvanic activity of the zinc anode and high and durable adhesion towards the concrete overlay.

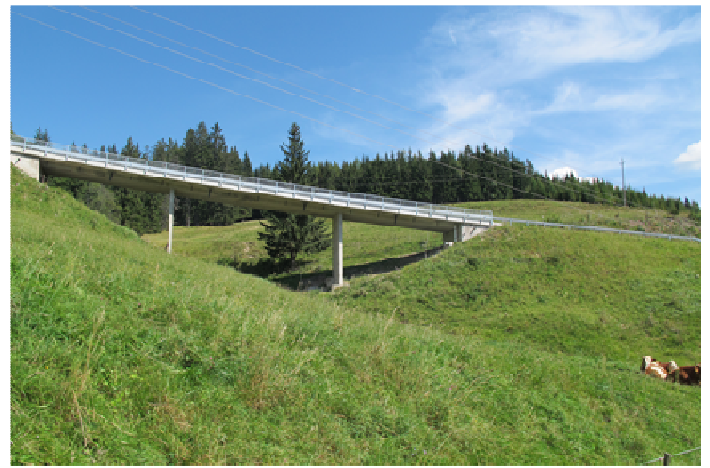
Figure 2. County road bridge “Alplgrabenbrücke” in the Styrian Alps on the county road B72.

The bridge structure showed visible concrete damages – cracks, spalling and corrosion - near the abutment “Birkfeld”. Water and saltwater during wintertime penetrated the bridge deck through cracks due to the bridge deck bumping against the abutment. Chloride contents of 4.0 – 5.6 wt. % / cement weight down to a depth of 2 cm were measured in the areas that were frequently wetted. In the less frequently wetted areas, the chloride content was in the range from 0.5 – 0.9 wt. % / cement weight, carbonation depth was ≥ 4 cm.

Therefore one has to assume high corrosion activity of the steel reinforcement of the concrete members with the risk of significant loss of cross section of the steel reinforcement in the future.

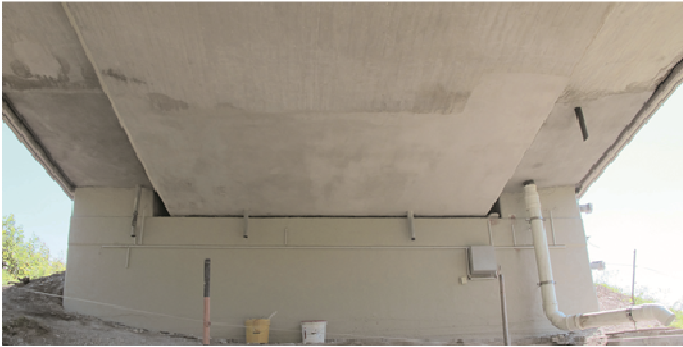
sented at the ICCRRR [8]. The data proved that the steel reinforcement is reliably protected from corrosion by the EZA system. The owner of the bridge – the Styrian department of bridge construction and repair – decided during the general bridge repair, executed from 21 June until 21 August 2012, to take over the EZA on the abutment. To assure frost thaw salt resistance and to increase performance, especially with respect to the galvanic chloride extraction, the EZA was coated with an elastic acrylic coating. In an area of about one m², the EZA was renewed by embedding a zinc mesh into the EZA binder on top of the existing EZA (figure 3).

Figure 3. View on the EZA installed on the abutment of the Alplgrabenbridge

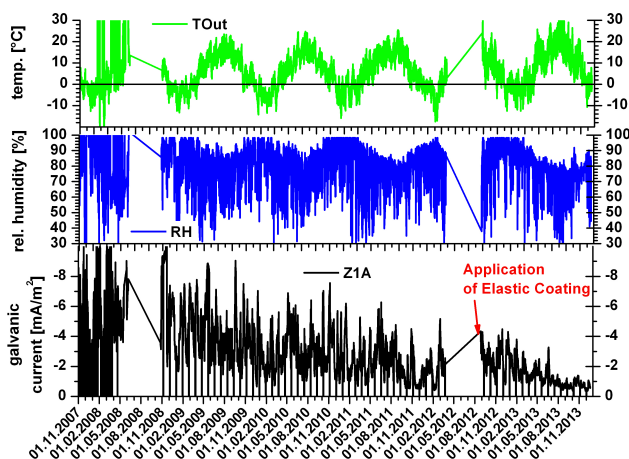
The operating data of the EZA-system over a period of more than six years (1 November 2007 – 19 December 2013) were evaluated and analyzed with respect to stability, performance and durability: The course of the galvanic current of the EZA-system show that the initially high galvanic currents decreased during the first three months continuously and stabilized after about 2 years (Figure 4).

Figure 4. Galvanic Current of the EZA-System in comparison with the ambient relative humidity (RH) and temperature (Tout). Data from 1 November 2007 till 19 December 2013.

The galvanic current decreased at dry ambient air (RH < 50%) and temperatures below freezing but increased immediately if humidity levels and/or temperature increased again to the values previously

measured at the corresponding humidity and/or temperature levels. Furthermore, the numerous wet/dry and freeze/thaw cycles did not affect the long-term performance of the EZA-system. The galvanic zinc anode protects the steel reinforcement reliably and durable from corrosion.

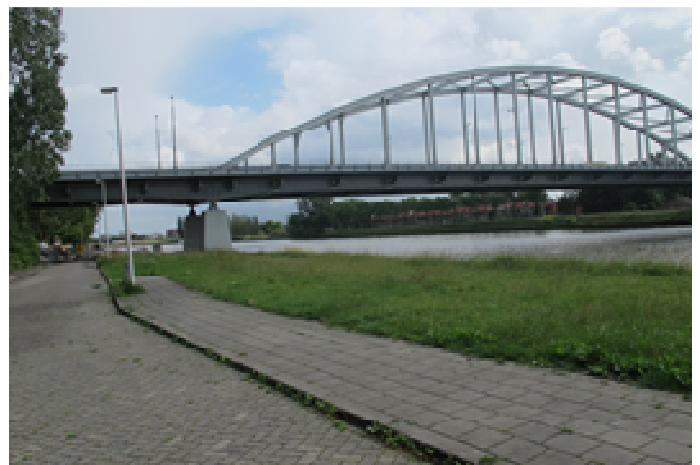
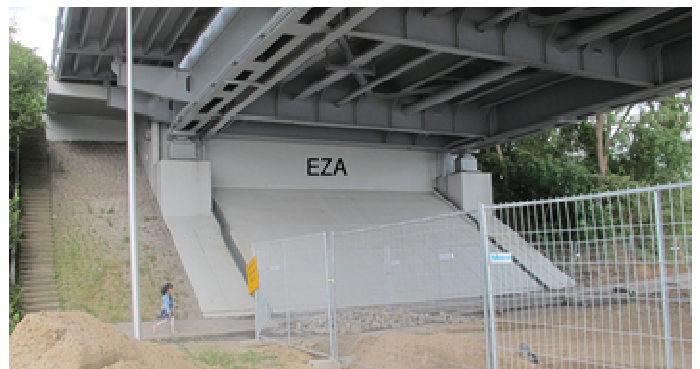
Figure 5. De Meerenbrugg steel bridge (top) in Utrecht with concrete abutments (bottom)

Reinforcement corrosion was initiated due to high levels of penetrated chloride readily available from de-icing salts from the overlying road. Over 1% mass of chloride by mass of cement was present at the rebar level in the damaged areas. Undamaged concrete showed high levels of chloride as well, but were slightly lower as in the damaged areas. During repair works a decision was made to change traditional repair work to cathodic protection.

The three main reasons were: reduction of direct costs due to the fact that traditional repair conforming to EN1504-standards would mean excessive removal of chloride contaminated concrete while cathodic protection would mean limited repair of delaminated and disintegrated spots; reduction of risks for future development of concrete damage on the none repaired locations and reduction of over-all execution time of the work being done. For the protection, some minor surface repairs were performed, after which a zinc mesh with a total amount of 4 kg zinc per m² of concrete surface was applied on a total of 200 m² concrete surface. The EZA system as applied was finalized with an aesthetic coating system based on the Sika Decadex system (figure 5). This is a typical installation of an “install and forget” system as there is no need for a power supply on this remote site and no need for extensive monitoring and control as the system is always “on”. Both issues were demands made by the department responsible for the future maintenance of the bridge. As inspected in 2013 the system’s performance is up to the industry’s standards.

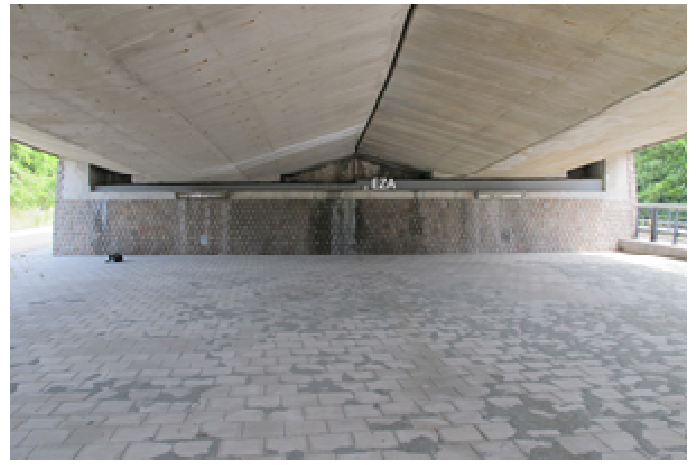
In total 90 m² was covered with zinc mesh with a total of 2 kg per m² of concrete (figure 6 & 7). Considering the low reinforcement density, a lifetime of over 10 years is expected. A total area of 90 m² of concrete was protected on 4 different locations, divided into 5 separate zones.

Each zone was installed with a decay-probe (activated titanium Ti*) and a reference-electrode (manganese dioxide MnO₂-type). All connections within a zone to the reinforcement, the zinc-anode, the decay-probe and the reference-electrode were made in a connection box. The entire surface was coated with the Decadex coating system.

Figure 6. EZA installed on the beams supporting the bearings of the Hubertus viaduct in The Hague

Table 1. Verification of the effectiveness of the GCP by the EZA by 24 h depolarisation measurements according to ISO EN 12 696. Potential values in mV, measured on beams shown in figure 6.

Date of meas.	Ref. Cell Type	On-potential	In-stant-off	4h off	24h off	24h Depol.
30 June 2011	MnO ₂	-547	-457	-386	-288	169
	Ti*	-366	-278	-183	-91	187
30 July 2013	MnO ₂	-551	-499	-404	-245	254
	Ti*	-356	-314	-237	-70	244

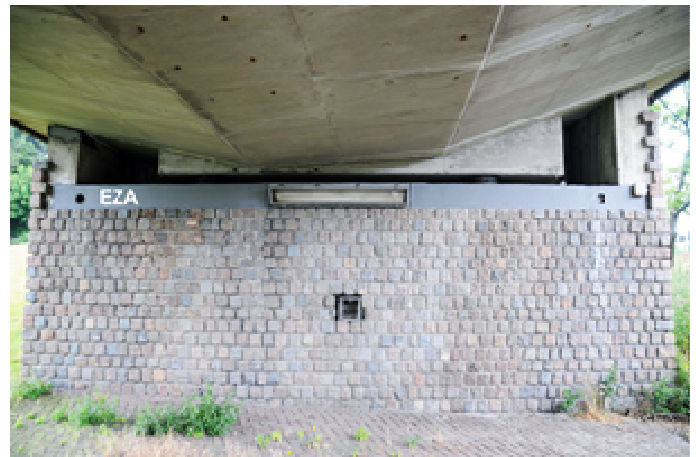
Figure 7. EZA installed on the beams supporting the bearings of the Hubertus viaduct in The Hague

Table 2. Verification of the effectiveness of the GCP by the EZA by 24 h depolarisation measurements according to ISO EN 12 696. Potential values in mV, measured on beams shown in figure 7.

Date of meas.	Ref. Cell Type	On-potential	In-stant-off	4h off	24h off	24h Depol.
30 July 2013	MnO ₂	-559	-507	-466	-327	-180
	Ti*	-288	-245	-194	-115	-130

Already after a few years, the joints had started to leak again and the EZA was exposed to deicing salt solution during wintertime. The EZA has outlasted six winters, four of them were harsh. Performance has been above expectation in the first 6 years. The system is capable of withstanding water load, de-icing salts, proves to be frost-thaw-resistant and shows no signs of aging.

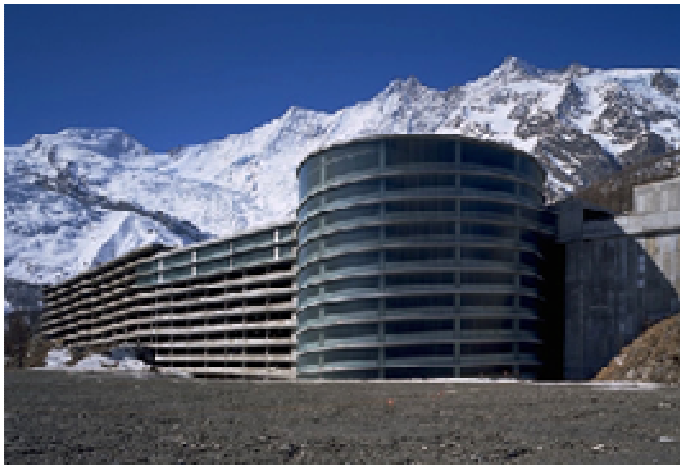
Figure 8. Central parking deck in Saas Fee, Switzerland

The parking garage in Saas Fee is designed to take in all cars of tourists and inhabitants of Saas Fee – Saas Fee is car free. The parking deck was erected 1979/80 and extended with a new section 1980/81, offering 2900 parking lots (figure 8).

The concrete overlay of the decks are impregnated with chlorides ranging from 0,5 – 3,0 wt.%/wt% cement near the loose steel reinforcement. The decks are reinforced with unbonded post-tensioned tendons. Conventional techniques would require the removal of with chloride contaminated concrete, coating of the steel reinforcement and refurbishment with repair mortar or concrete. This procedure would be highly delicate with regard to the unbonded tendons in the parking deck – damage to these tendons has to be avoided under any circumstances. With re-

gard to the pre-stressed tendons and the risk of CP induced hydrogen embrittlement, galvanic corrosion protection offers a safe and reliable remediation technique. In July 2011, on a parking booth, the EZA system was installed on 30 m² concrete surface. The EZA system has been coated with a tough elastic, static crack-bridging waterproofing and wearing surface layer of broadcast total solid epoxy Sikafloor-390, covered by a high abrasion resistant sealcoat of total solid epoxy Sikafloor-354 (figure 9).

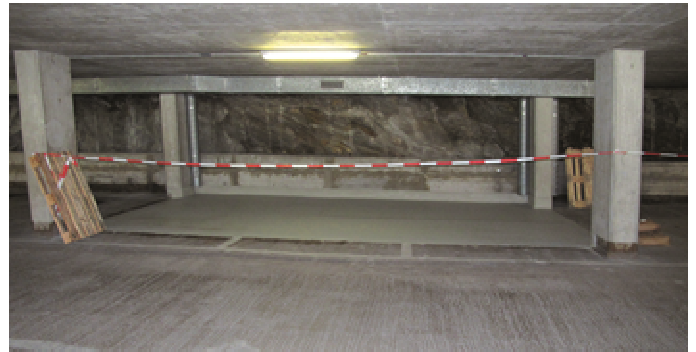
Figure 9. EZA-installation in one parking booth

The EZA is now in operation since August 2011, exposed to the harsh alpine conditions in 1880 m above sea level. Data show that it is protecting the steel reinforcement reliably and safely with 0-maintenance expenditures.
