Maintaining and monitoring durable cathodic protection systems applied on 30 concrete bridges with prestressing steel

This paper describes the experiences of the maintenance and monitoring of an innovative cathodic protection project named ‘Liggerkoppen’ (which translates to ‘beam heads’). The application phase of the project is covered in the paper ‘Application of durable cathodic protection systems applied on 30 concrete bridges with prestressing steel’ as presented on ICCRRR 2015.

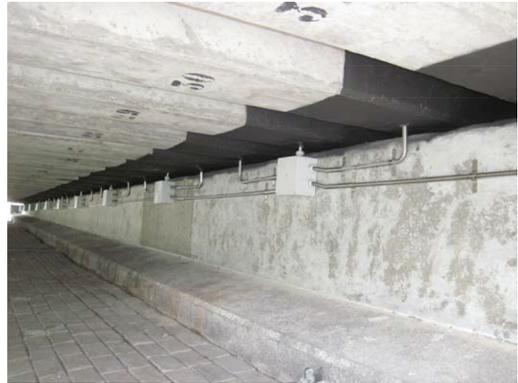
Figure 1. As-built CP system with conductive coating and decentralized power supply and monitoring units.

Based on the set demands in the tender documents, a CP system was designed based on a conductive coating as anode system. The applied conductive coating consists of a graphite filled aluminosilicate matrix (non cementitious binder) with good strength, adhesion and long term durability when used as an anode. As a primary anode a platinum clad copper wire was used (CuNbPt). Each beam head has its own connection tot the reinforcement steel (since there typically was no electrical continuity between beams). Each beam head was equipped with (2 or 3) reference electrodes for monitoring purposes (Fig. 1).

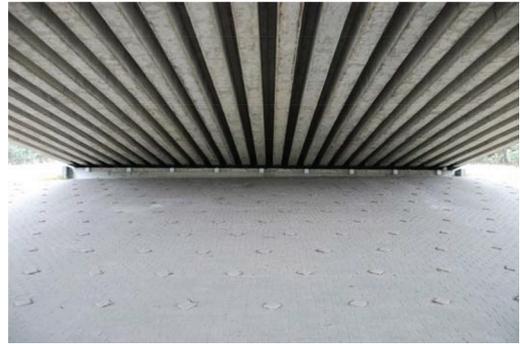
Figure 2. Example of as-built CP system at abutment on 27 beams with 9 decentralized power supply and monitoring units.

The number of beams which are equipped/provided with impressed current (‘active’) cathodic protection varies from merely 3 to over 170 beams per bridge (Fig. 2). In total the project involves an amount of over 1.500 prestressed beams of the total amount of almost 6.000. Every beam is designed as separate ‘field’ (or pseudo-zone) and contains at least two reference cells (occasionally

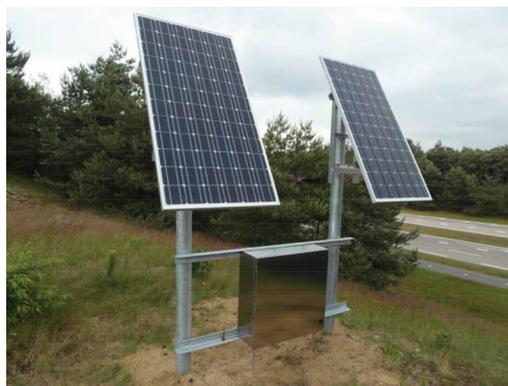
Figure 3. Central measuring and control unit and solar panels.

Frequently the status of each zone is checked (so-called 'on' measurements), confirming the good operation of the hardware which are especially important due to the fact that these CP systems operate on solar power (Fig. 3). These measurement typically generate data of set voltage, applied voltage, applied current, and the on-potentials of the reference electrodes: typically 4.500 numbers per measurement. Combined with a weekly interval for measuring, this will result in 234.000 numbers per year (4.7 million during the total maintenance period).
