# Rehabilitation, repair, and maintenance of carbonated concrete members affected by corrosion of reinforcing steel by applying CP via a composite quantum anode.

## 2 Examples for the application of CP for the corrosion protection of steel in carbonated concrete elements

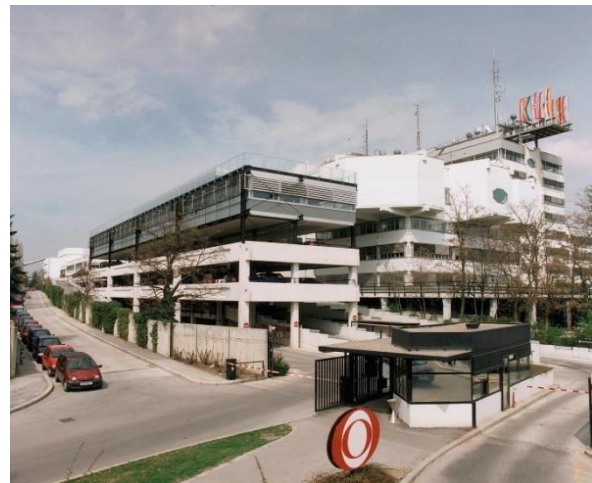
The parking deck at the centre of the Austrian TV (ORF) administration in Vienna (Fig. 1) was constructed between 1968 and 1972, based on Roland Rainer's plans, and is protected as a historic monument. The concrete structure of the parking deck showed damage typical of the carbonation-induced corrosion of the steel

**Fig. 1.** View on the parking deck structure of the administrative centre of the ORF in Vienna, Austria.

Cathodic protection with conductive paint - the Composite Anode System - was chosen as it stopped the deterioration of the critical parking deck structure with minimal interference to the ORF employees' use of it. From October 2002 to July 20008, the Composite Anode System was installed in 20 protection zones on a total surface area of 1200 m<sup>2</sup>.

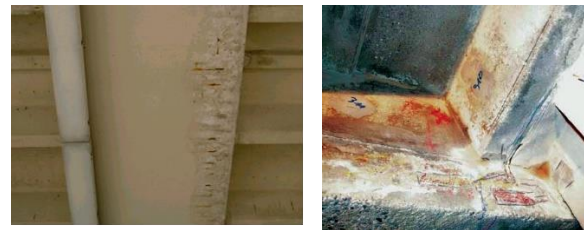
reinforcement, such as spalling and cracking of the soffits and deck ceilings (Fig. 2).

**Fig. 2.** Concrete damage caused by the steel reinforcement corrosion induced by the concrete cover carbonation.

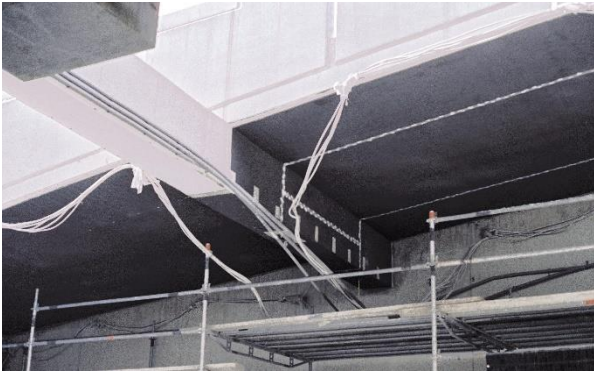
**Fig. 3.** Application of the CAS-T Composite Anode on the soffit of the drive-in ramp of the ORF parking garage

The Composite Anode Paint CAS-T, the parent to CAST<sup>Q</sup> composite quantum anode paint, was applied with rollers in two layers on the CAP60 primer-impregnated concrete surface. Current distribution was achieved by embedding Cu/Nb/Pt wires ( $\varnothing 0,8$  mm) into the CAS-T paint (Figure 3). The Composite Anode was covered with an elastic acrylic top coat Stocryl V200 (Fig. 4 to 6).

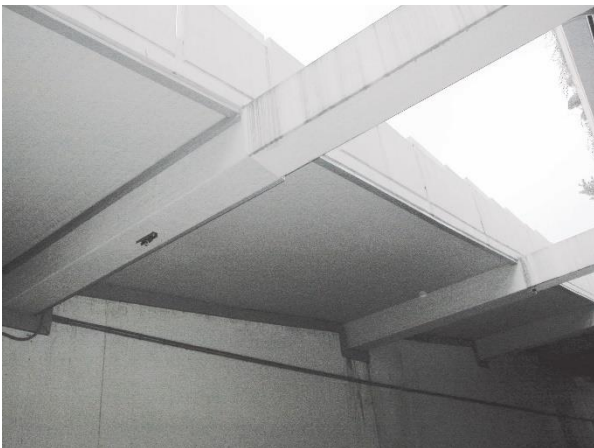
**Fig. 4.** CAS-T Composite Anode covered with a polyacrylic cover coat on the soffits and beams of the drive-in ramp to the ORF parking garage.

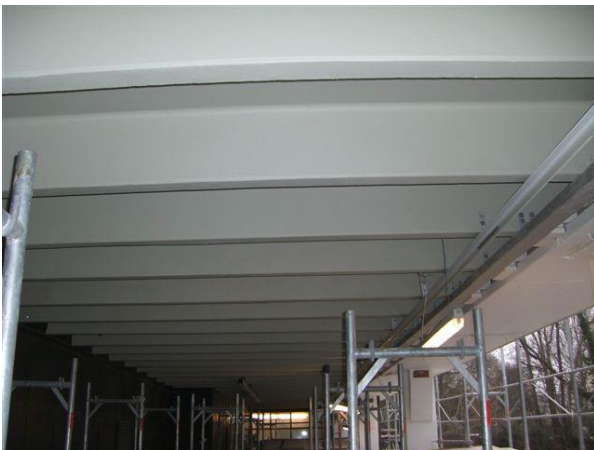
**Fig. 5.** CAS-T Composite Anode applied to concrete beams and soffits, covered with an elastic acrylic cover coating.

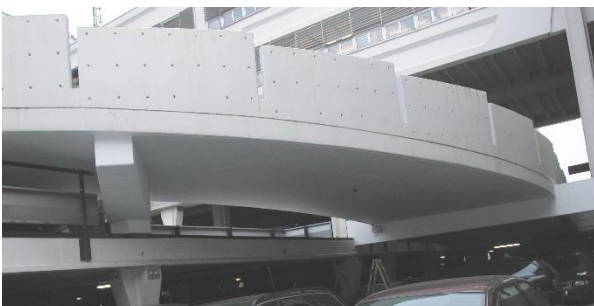
**Fig. 6.** CAS-T Composite Anode applied to beams and soffits, covered with an elastic acrylic cover coating.

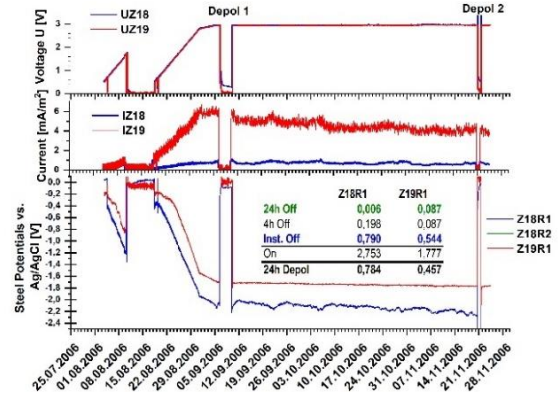
**Fig. 7.** Start-up and initial operational data for protection zones 18 and 19.

Figure 7 shows typical start-up and initial operational data. Carbonated concrete has a higher resistivity because with calcium- and hydroxyl- ions as calcite important charge carrier are removed from the pore solution and pore volume is reduced. Subsequently, higher voltages (3–5 Volts) have to be applied to assure protection according to EN ISO 12 696. After 4-10 years of the CAS-T Composite Anode operation, operational data are listed in Table 1. Except for protection zone 5, the protection zones 2–13 are fully protected according to EN ISO 12 696. Depolarisation measurements were not possible in the protection zones 14–20 due to the installation of high-power equipment in the nearby offices, emanating strong electromagnetic waves. Using shielded cables to the reference cells only lowered the impact. The operational data (voltage, current) conforms with the protection zones 2 – 13, so one may assume the corrosion protection is safe. The maintenance contract with the owner expired in 2012.

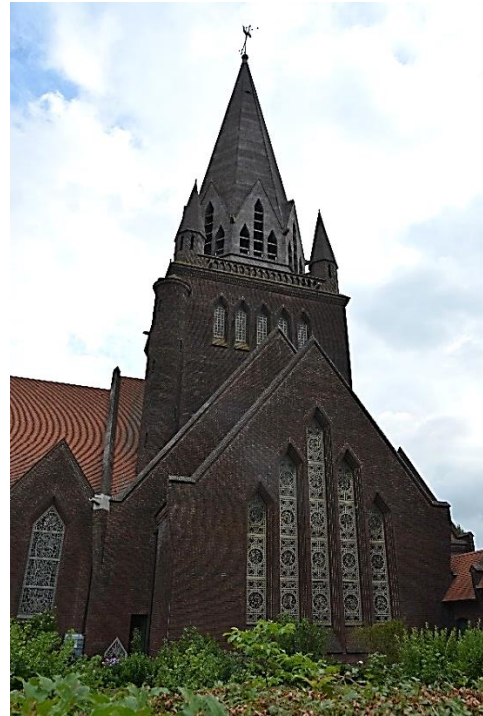
The Sint-Theodardus Church (Fig. 8), designed by Henry Lacoste and built between 1939 and 1943, is one of Belgium's five mining cathedrals and holds protected heritage status due to its monumental value. Located on Koolmijnlaan in Beringen-Mijn, Limburg, the church is a single-nave cruciform structure featuring a 72-meter-high tower and distinctive glass-in-concrete windows. The windows, constructed with an experimental technique, exhibited severe damage due to carbonation of the cement stone and insufficient concrete cover over the steel reinforcement. This degradation also caused secondary damage to the glass elements, with some being affected by salts.

Fig. 8. Sint-Theodardus Church in Limburg, Belgium, elements protected with CAST<sup>Q</sup> Composite Anode, details see figure 9 below.

During the 2017-2018 restoration, 36 concrete window panels (Fig. 9 and 10) from the nave and baptistery were repaired. Approximately 3,000 damaged glass pieces were replaced out of a total of 8,000. Severely deteriorated panels were fully disassembled, and new concrete frames were reconstructed before reassembling the original glass elements. In contrast, panels in better condition (the "tips") underwent localized glass repairs and installation of a cathodic protection (CP) system to halt steel corrosion, preserving the original construction.

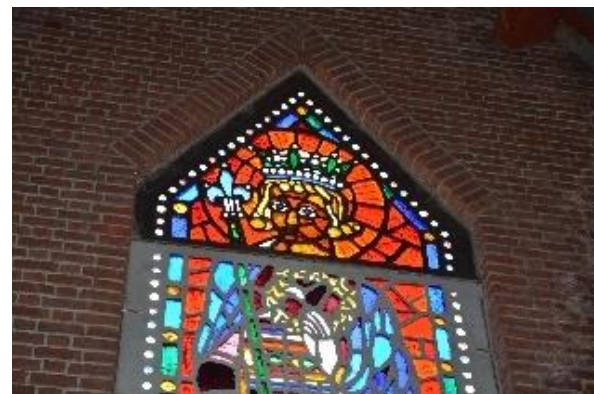
Fig. 10. Element protected with the CAST<sup>Q</sup> Composite Anode

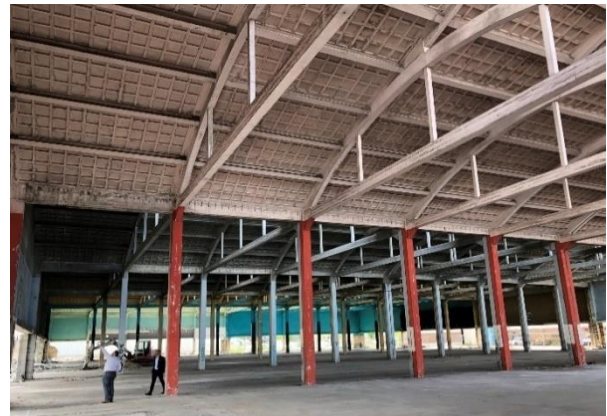
The main structure consists of concrete columns, arches, and beams. The roof structure consists of purlins with prefabricated roof panels resting on them, forming a cassette ceiling (Fig. 13).

Fig. 13. Concrete elements of the main structure on the interior

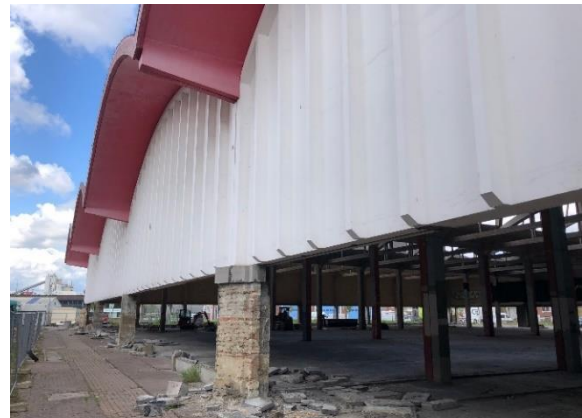
On the exterior 7 arch-shaped concrete roof elements, with cantilever beams, are visible, as well as concrete columns, beams and façades with slender reinforced ribs (Fig. 14).

Fig. 14. Concrete elements of the main structure on the exterior

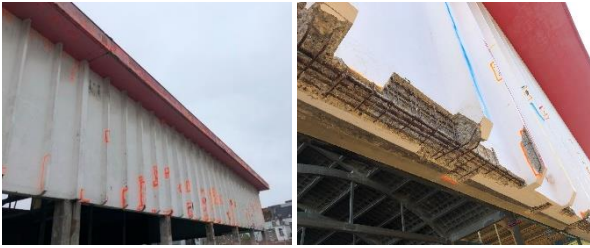
**Fig. 15.** Concrete damages due to carbonation

Over time, the building fell out of use as a slaughterhouse and the plan was recently conceived to reuse the monument for the benefit of the campus of a school of higher education. As the concrete showed widespread damage and this was undesirable for future use, a concrete survey was carried out in 2021. This revealed that the damage had been caused by carbonation (Fig. 15). The concrete cover on the steel varied widely from 5-99 mm. The average measured carbonation depth in 2021 varied from 30 to 150 mm inside (often the concrete was thoroughly carbonated) and from 22 to 71 mm outside. Particularly outside, the measured values varied greatly, from sometimes 0 mm to 100 mm (with carbonation through and through). No chlorides were present in the concrete.

As no future problems with the concrete in the (dry) interior were expected, the repair and prevention of future damages focused mainly on the exterior. Sustainable repair of carbonation damage is 'traditionally' quite possible by removing all the carbonated concrete, where necessary up to behind the reinforcement. However, for many slender elements and sections in the structure, such as the fragile concrete ribs in the façade elements, this would lead to severe damage to the monument and sometimes to complete demolition, which is undesirable in a historical monument. Moreover, large sections of concrete that are still attached and undamaged (but carbonated) by themselves would have to be removed. In addition, the structural function could be compromised at the roof overhangs and the beams, load-bearing elements with a large span, through chiselling work (up to behind the reinforcement). Thus, traditional concrete repair results in extensive and costly rehabilitation and repair work. The ribs, in particular, would be challenging to repair.

Therefore, CP with impressed current became a real and (also economically) attractive repair option. The carbonated concrete does not have to be removed up to behind the reinforcement, as the reinforcement will be protected in another way. Only the already loose and delaminated concrete parts of the cover need to be removed and repaired beforehand. This resulted in less labour-intensive, extensive and costly repairs (Fig. 16).

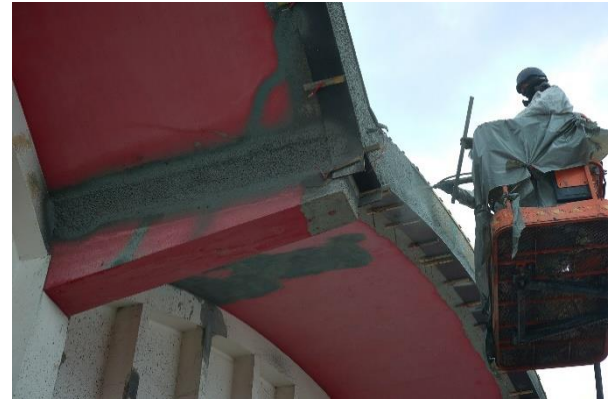
**Fig. 16.** Concrete repair with shotcrete at a roof element

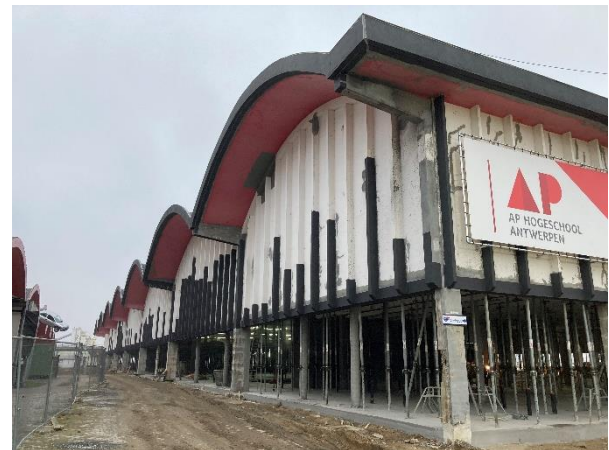
**Fig. 17.** Applied anode material (black conductive coating) on ribs, beams and roof elements

Conductive coating, CAST<sup>Q</sup>, was chosen as the anode material (Fig. 17 and 18). Approximately 1,000 m<sup>2</sup> was thus provided with anode material and the system, divided into five zones (2 zones with roof edges and cantilever beams, 2 zones with façade beams with ribs and 1 zone with the roof superstructures). The works were delivered by Vogel BV on 1 June 2022 and all zones started up with an initial 2 Volt and were adjusted in steps up to 4 Volt. By December 2022, all zones were commissioned and the measured values are shown in Table 2.

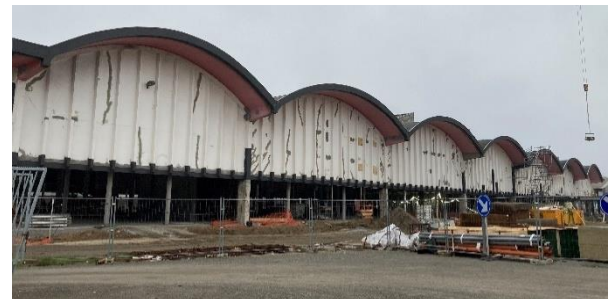
**Fig. 18.** Applied anode material (black conductive coating) on roof elements and ribs

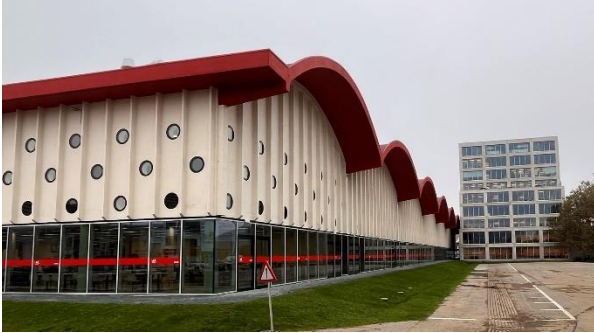
Fig. 19. The historical monument after renovation

Figures 19 to 21 give an impression of the end result.

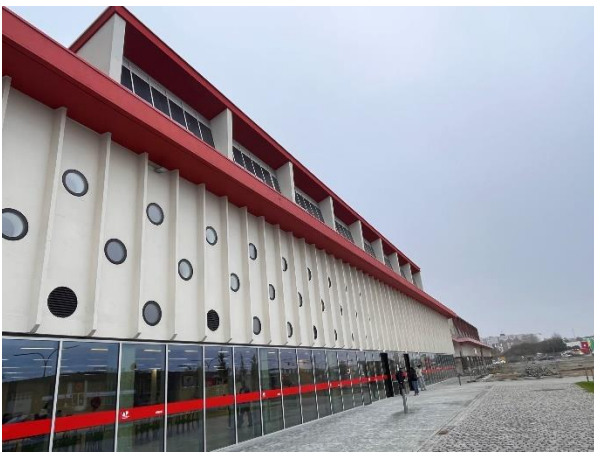
Fig. 20 The main entrance of the campus

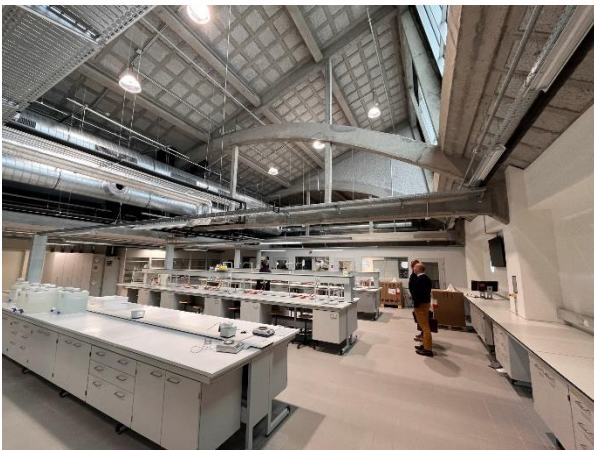
Fig. 21. The interior after the renovation

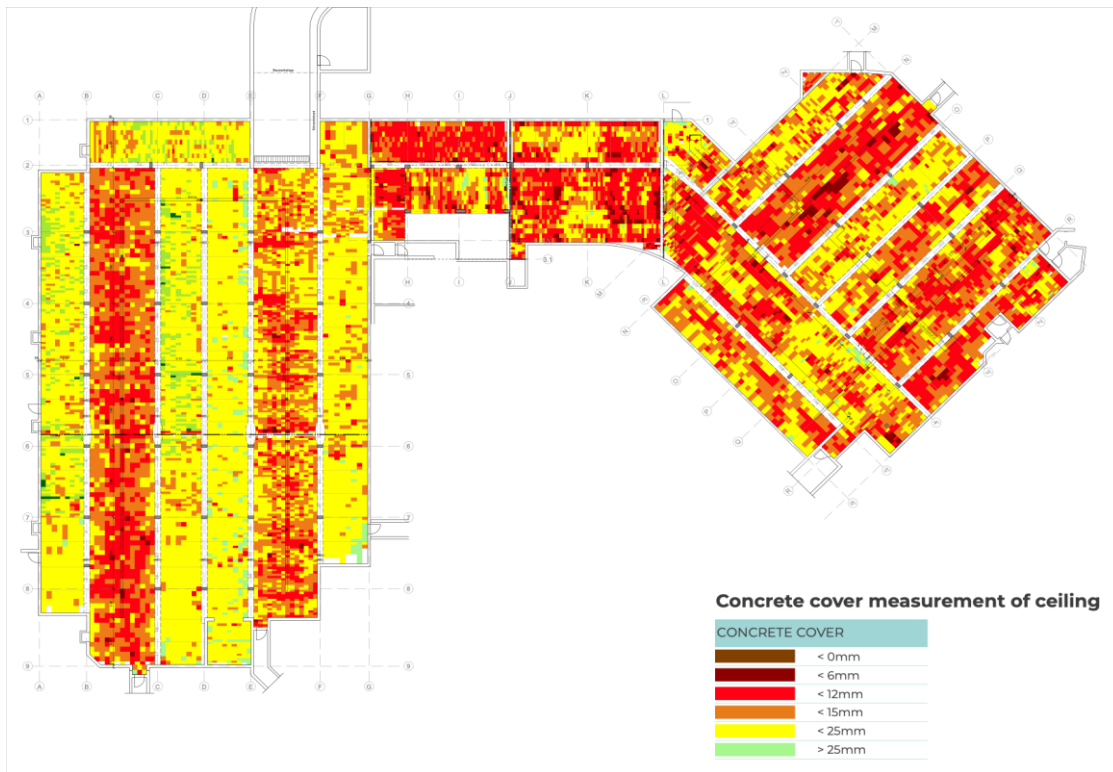
The average carbonation depths obtained from the measurements are used to assess the corrosion risk due to carbonation. The results of the concrete cover measurements (see Figure 23) in conjunction with the component-specific carbonation depth indicate:

- 56.6% of the ceiling reinforcement (concrete cover *c* ranging from 7 mm to 75 mm, with an average of 26 mm) is at risk of carbonation-induced corrosion (average carbonation depth: 25 mm).
- 45.9% of the beam reinforcement (concrete cover *c* ranging from 0 mm to 93 mm, with an average of 33 mm) is also at risk of carbonation-induced corrosion (average carbonation depth: 25 mm).

**Fig. 23.** Cover Measurement Plan - Ceiling Underside

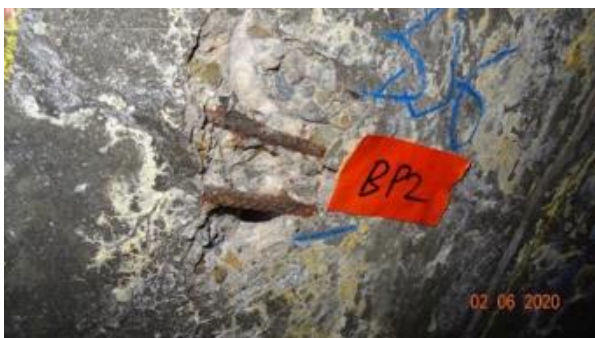
Probes taken at BP 02 (ceiling) and BP 03 (beam) confirmed active corrosion processes in the reinforcement.

- These are attributed to concrete carbonation down to the reinforcement depth (carbonation depth: 18 mm / 24 mm).
- The presence of moisture, which contributes to the corrosion process.

**Fig. 25.** Image: Exploratory Openings

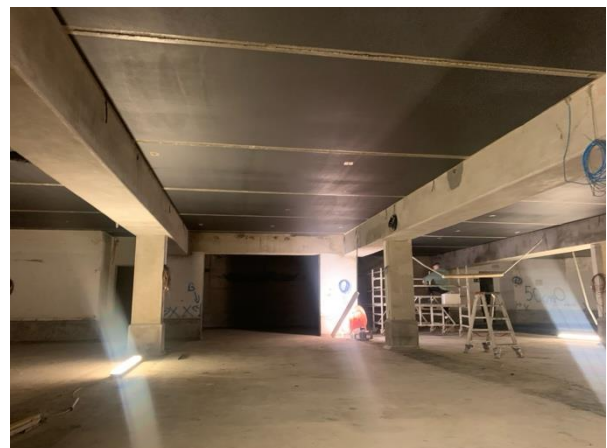
Fig. 28. Application after hardening of CASTQ

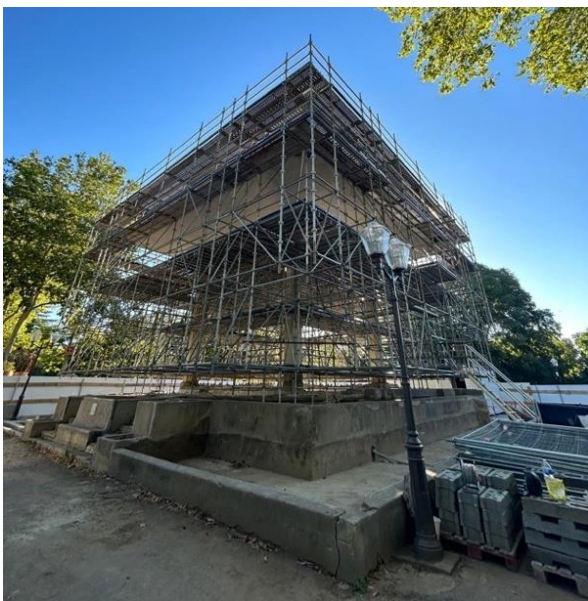
The Bosc Kiosk, located on Jean de Lattre de Tassigny Alley in Montpellier, France, is an iconic structure built in 1927 (Fig. 30). The kiosk exhibits a distinct architectural style, characterized by four octagonal columns supporting a circular beam and a reinforced concrete shell. Due to its exposure to environmental conditions over nearly a century, the structure has suffered significant corrosion caused by carbonation. An impressed current cathodic protection (ICCP) system using a carbon-based conductive coating, the CAST<sup>Q</sup> Composite Quantum Anode, was implemented to ensure its long-term preservation while maintaining its original aesthetics.

**Fig. 30.** Overall picture of the Bosc Kiosk in Montpellier.

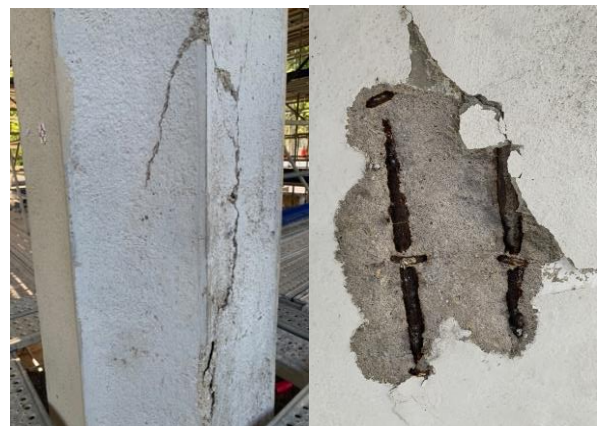
A thorough corrosion assessment was conducted in mid-2024, revealing advanced and widespread carbonation throughout the structure. The diagnostic report indicated that the carbonation front had surpassed the reinforcement depth, causing a decrease in concrete pH and initiating corrosion (figure 28). However, chloride contamination (0,01 – 0,02 wt.%/wt. cem.) was found to be below critical thresholds, ruling out chloride-induced corrosion as a contributing factor

**Fig. 31.** Cracks and spalling due to corrosion of steel rebars initiated by carbonation of their concrete cover.

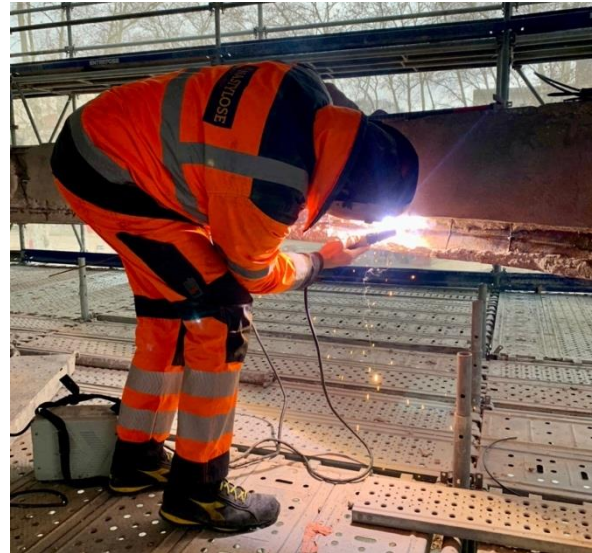
One of the project's major challenges was restoring the continuity of the reinforcement. Indeed, no transverse reinforcement was continuous with the longitudinal reinforcement of the circular beam. To address this, an additional reinforcement bar was installed on the inner face of the beam and welded to each stirrup (Fig. 33). All missing concrete was reconstituted using repair mortar in compliance with the EN 1504-2 standard for concrete and mortar repair.

**Fig. 33.** Welding of the stirrups to an additional circular rebar to ensure steel continuity.

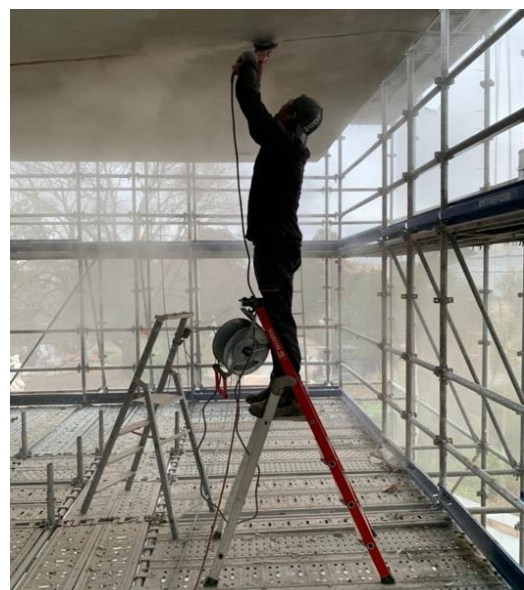
**Fig. 34.** Preparation of the grooves to dissimulate the XLPE/XLPE cables.

- 1) QAP 60 Primer application for enhanced adhesion and contact.
- 2) Installation of primary anodes (Ø 0,8 mm Cu/Nb/Pt wire):
  - Shell underside: Embedded in shallow grooves (Fig. 34).
  - Circular beam: Concealed in a corner of the complex beam section.
  - Roof structural beams: Positioned on the top surface without grooves, as these are not visible and thus do not require aesthetic treatment.
- 3) Secure connections using insulated splices to XLPE/XLPE cables embedded in the concrete, routed to the junction box (Fig. 35).
- 4) Application of two layers of CAST<sup>Q</sup> paint ensuring uniform conductivity.
- 5) Final acrylic decorative coating to meet the architectural aesthetic requirements.

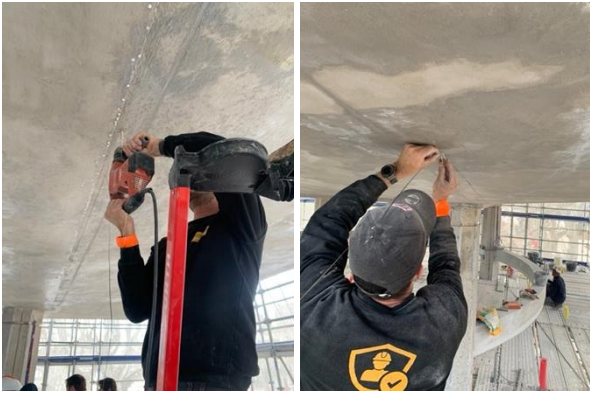
**Fig. 35.** Installation of one of the primary anodes.

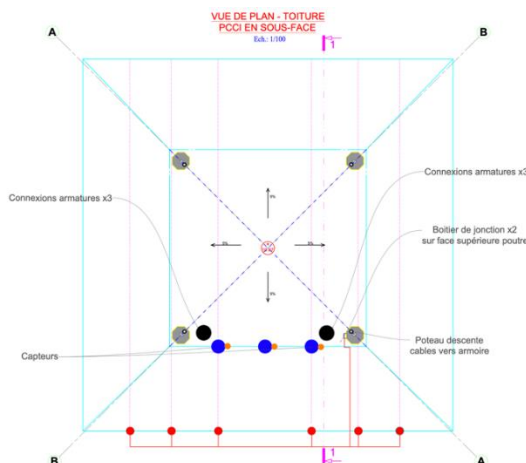
The effectiveness of the carbon-based conductive coating is optimized through careful spacing of the primary anodes, ensuring uniform current distribution. Given that the perimeter of the beam sections is less than 2 meters, a single primary anode was used per beam section for both the roof beams and the circular beam. For the shell underside, the surface was divided into two anodic zones, each treated with three primary anodes distributed evenly to ensure uniform protection (Fig. 36).

**Fig. 36.** Design of the shell underside – 2 anodic zones, 6 primary anodes.

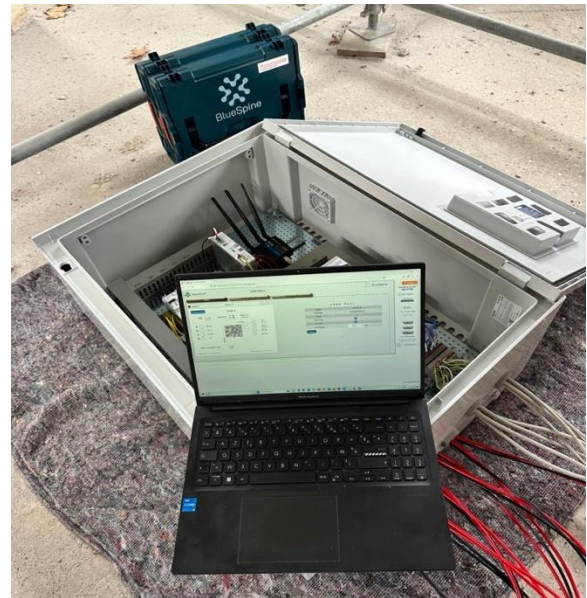
**Fig. 37.** Real-time data acquisition using an advanced automated monitoring system.

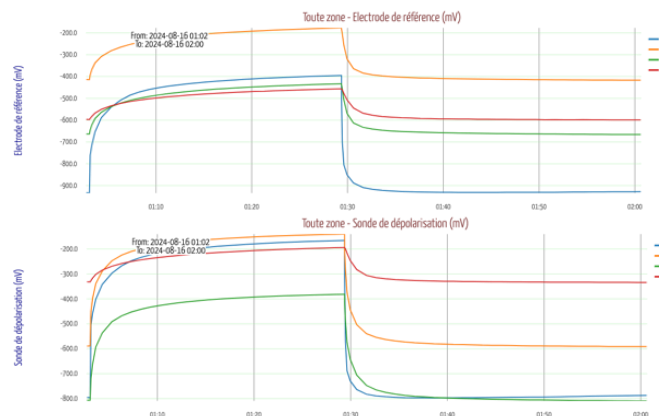
- Stable polarization levels before power shutdown.
- Consistent potential recovery curves after power interruption.
- Homogeneous distribution of protection current across all anode zones.

**Fig. 38.** Performance verification – depolarization data through reference electrodes and decay probes.
