Application of cathodic protection on 30 concrete bridges with pre-stressing steel: Remaining service life extended with more than 20 years

ABSTRACT: In view of long term maintenance of its infrastructure facilities the Dutch Highway Administration (Rijkswaterstaat) has repaired over 1.500 heads of prestressed beams and provided them with cathodic protection (CP). The heads of these beams showed moderate to severe damage due to reinforcement corrosion caused by the penetration of chlorides from leaking joints, which required adequate intervention on the short term. By means of cathodic protection the corrosion process has been halted, so that the risk of further degradation of the beams and possible failure of the pre-stressing steel tendons has been minimized. In addition, the concrete repairs in the chloride contaminated parts of the beams will be durable.

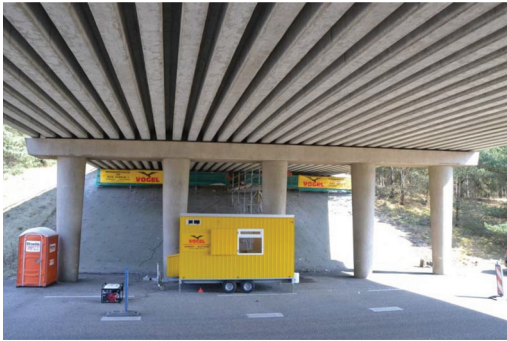
Routine inspections of various bridges in and over a number of highways revealed that a significant number of bridges showed serious damage at the ends of the prestressed concrete beams supporting the decks. A large number of these beams exhibited cracks and spalling of the concrete cover as well as rust stains at the end of the beam. It was identified that the bridges affected by this problem were built between 1965 and 1976. The decks of these bridges are supported by so-called prefabricated 'contact-beams', i.e. prestressed concrete T-shaped beams, which were also prestressed as a group in transverse direction. This structural solution results in a bridge deck without necessitating a structural concrete layer on top (Fig. 1).

Figure 1. Typical bridge in the project with ‘contact-beams’.

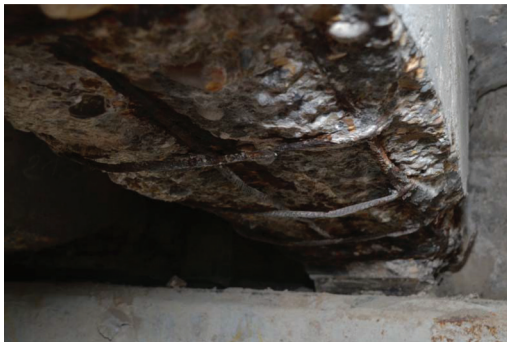
Further investigations showed that the cause of this damage was reinforcement corrosion initiated by chlorides. Due to leakage through the joints, the heads of the beams were exposed to wet conditions and during winter months to run-off water contaminated by chlorides from de-icing salts. Even though the concrete quality of the prefabricated

beams was high, demonstrated by carbonation depths which did not exceed 4 mm, the deep penetration of chlorides combined with a moderate concrete cover thickness (with an average of about 25 mm) had eventually resulted into corrosion of the outer mild steel reinforcement. As a consequence, the concrete cover was spalling, particularly in the corners behind the support blocks and near the anchors of the pre-stressing steel tendons (Fig. 2).

Figure 2. Concrete damage and corrosion of mild steel reinforcement.

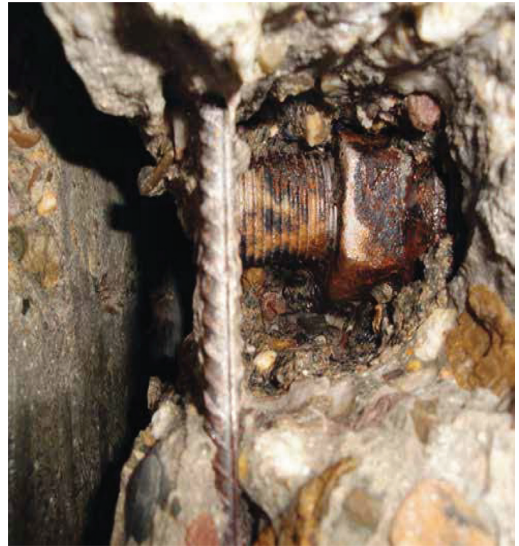
The beams are prestressed with a DYWIDAG system, which consists of 3 to 6 tendons per beam. These tendons are anchored with a steel plate and a nut. Since there was a risk for the pre-stressing system to be corroded, a destructive study was performed by SGS Intron to investigate the condition of the anchors. A part of the concrete behind the anchor was removed by hydro-jetting in order to have a better impression of the effects of corrosion. The results from this inspection showed that the anchors were corroded. However, this was mainly superficial corrosion without significant material loss (Fig. 3).

Figure 3. Surface corrosion of an anchor of a pre-stressing tendon.

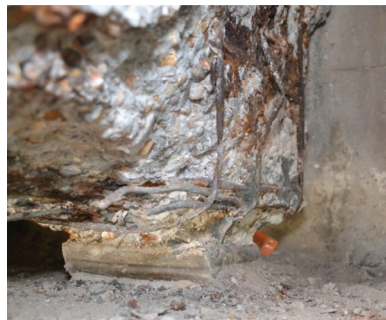
The first step was to remove all loose concrete parts. In some beams it was found that the concrete was affected to such an extent that at the bottom only a pyramid-shaped pressure area directly above the support remained (Fig. 5).

Figure 5. Severely damaged beam head after removing delaminated concrete.

If a large decrease (>10%) of the concrete contact surface area was revealed during restoration of

the damage, an assessment of the structural safety was made by Royal HaskoningDHV, after which the beam head was eventually restored in compliance with a prescribed procedure.

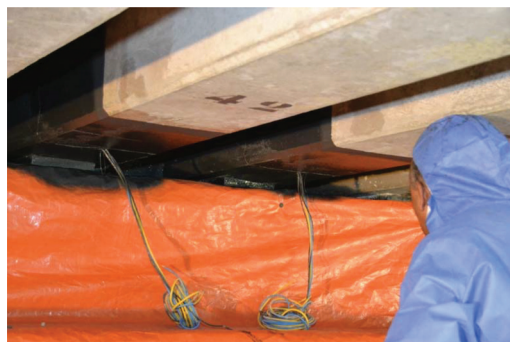
Figure 8. Applying the conductive coating (CAST³⁺ system).

After curing of the repair mortar a conductive coating (the CAST³⁺ system, a 2-component aluminum-silicate polymer filled with carbon) was applied as a (secondary) anode to the concrete surface of the beam head (Fig. 8). In this coating a primary current carrying anode (a CuNbPt-wire) was incorporated.

This type of anode was chosen because of the long-time experience with the material in similar conditions, the durability of the conductive coating in relation to the requested lifetime of 20 years,

good practical experience, and the advantages of a conductive coating with regard to the application in the restricted work space between the beam heads. Taking into account this tight working space it was chosen to apply the coating by spraying it on the concrete surface in 2 layers.

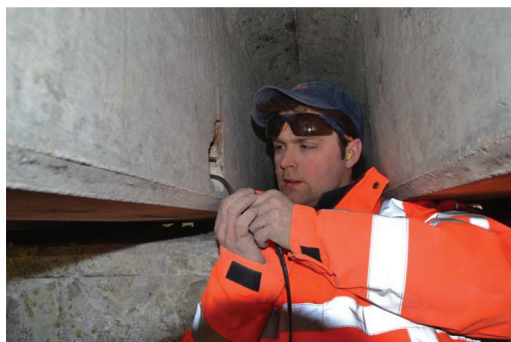
Figure 7. Restricted work space for concrete repair and CP installation.

Especially the restricted work space, the deep position of the beam heads at abutments, and the fact that at some locations the execution had to take place at night, complicated the repair work (Fig. 7).

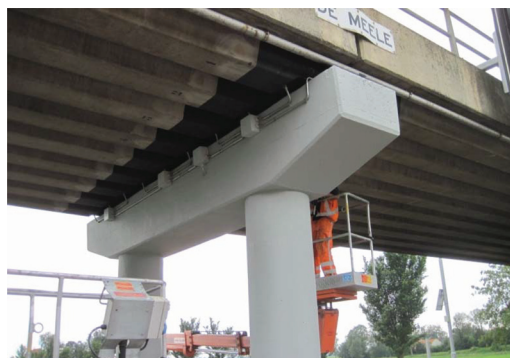
Figure 9. As-built CP system with 4 decentralized power supply and monitoring units.

The reference electrodes and the connections for both anode (1) and cathode (2) were installed and connected per 2 or 3 beam heads to a decentralized power supply and monitoring unit (Fig. 9).

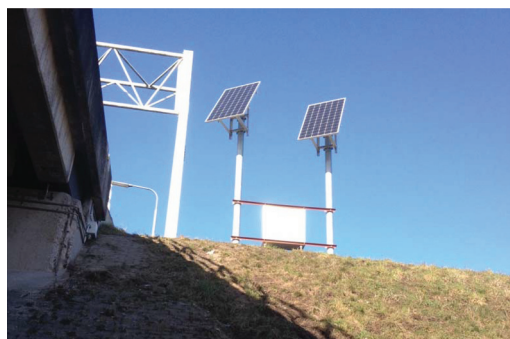
Figure 10. CP system with central measuring and control unit and solar panels.

This unit was connected with a data cable and power cable to the central measuring and control unit (Fig. 10). The decentralized units collect and store the measurement results for the connected beams and these results can be approached, read, collected and programmed remotely through the modem in the central control unit. Furthermore, the voltage applied on the CP system can, depending on the results of the measurements, be adjusted remotely as well, per every decentralized unit (through the modem in the central unit). The data and power cables are concealed in stainless steel pipes.

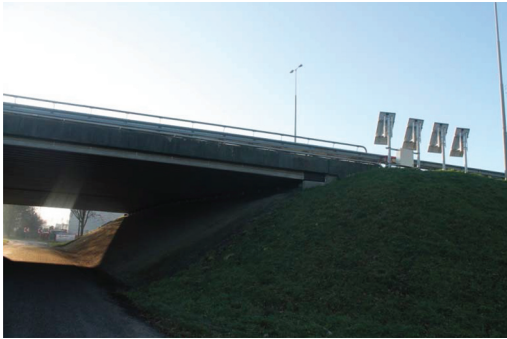
Figure 11. Solar panels.

The power of the CP system is, at most locations, provided by a double battery, which is fed by solar panels (Fig. 11). At four locations an exception was made due to the local conditions (shade, buildings, afforestation, pipelines). Here the CP systems are connected to the main electric grid.
