MAINTENANCE AND REPAIR OF STEEL REINFORCED CONCRETE STRUCTURES BY SIMULTANEOUS GALVANIC CORROSION PROTECTION AND CHLORIDE EXTRACTION – FIELD EXPERIENCES

W. Schwarz¹), F. Müllner¹), A. van den Hondel²)

¹CAS Composite Anode Systems GmbH, Vienna, Austria

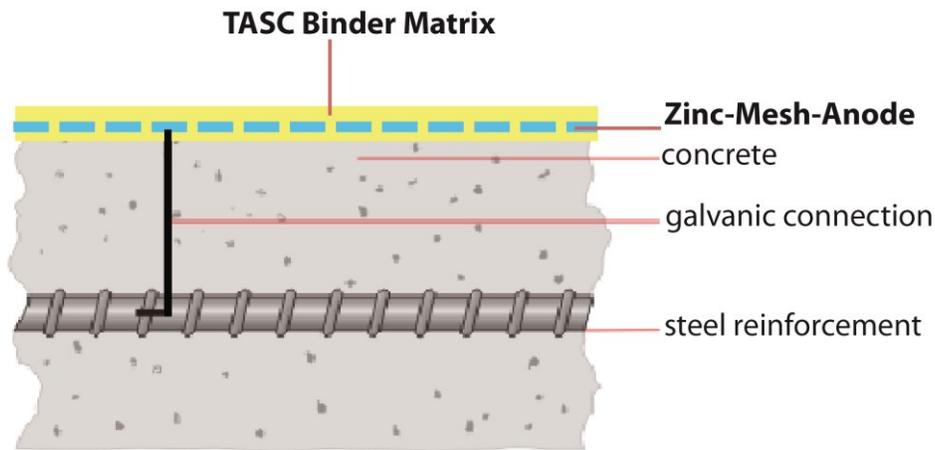
Figure 1. Embedded galvanic zinc anode (EZA): zinc mesh embedded into the EZA binder matrix

The galvanic EZA system is composed of a zinc mesh embedded into the proprietary solid electrolyte (figure 1). The TASC binder matrix is formed by the hardening of the hydraulic binder containing tecto-alumosilicate-cement. The TASC binder matrix functions as a solid electrolyte, that ascertains an optimum electrolytic contact between the zinc anode and the concrete overlay, it prevents the self-passivation of the zinc anode and therefore assures an optimum and reliable protection of steel reinforcement endangered by, or already damaged by chloride induced corrosion.

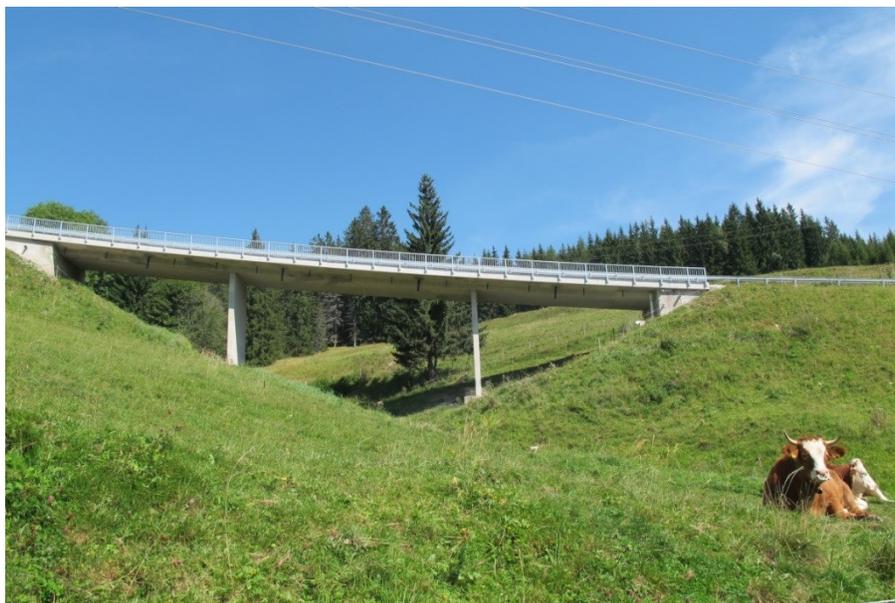
Figure 2. County road bridge "Alplgrabenbrücke" in the Styrian Alps on the county road B72.

For the evaluation of the efficiency and durability of the EZA system, a road bridge in an alpine region of Styria (Austria) was chosen (figure 2) for the following reasons:

The bridge is located in the Styrian Alps in an altitude of 1000 m above sea level. The climate in that region is characterized by rapid wetting and drying cycles with large temperature differences in the summer including temperature changes crossing the thaw point and by frequent frost-thaw cycles with high exposure to de-icing salt during winter.

The bridge structure showed visible concrete damages – cracks, spalling and corrosion - near the abutment “Birkfeld”. Water and saltwater during wintertime penetrated the bridge deck through cracks due to the bridge deck bumping against the abutment. Chloride contents of 4.0 – 5.6 wt. % / cement weight down to a depth of 2 cm were measured in the areas that were frequently wetted. In the less frequently wetted areas, the chloride content was in the range from 0.5 – 0.9 wt. % / cement weight, carbonation depth was ≥ 4 cm at a concrete cover of 20 – 40 mm.

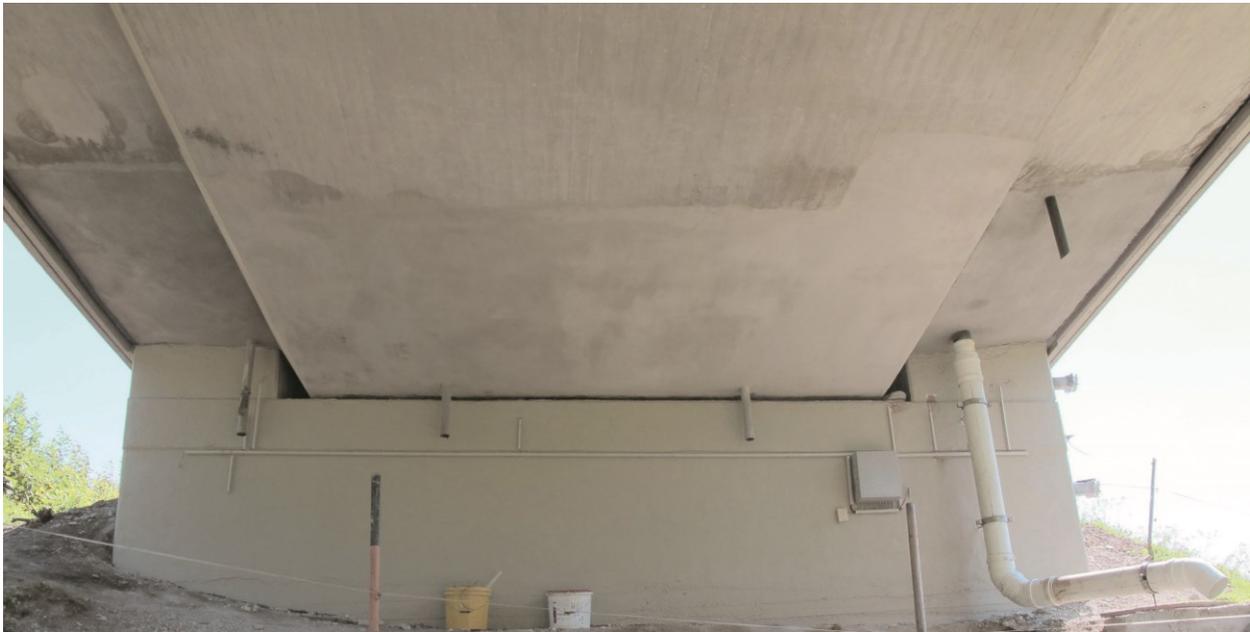
Figure 3. View on the EZA installed on the abutment of the Alplgrabenbridge

The data proved that the steel reinforcement is reliably protected from corrosion by the EZA system. The owner of the bridge – the Styrian department of bridge construction and repair – decided during the general bridge repair, executed from 21 June until 21 August 2012, to take over the EZA on the abutment. To assure frost thaw salt resistance and to increase performance, especially with respect to the galvanic chloride extraction, the EZA was coated with an elastic acrylic coating. In an area of about one m², the EZA was renewed by embedding a zinc mesh into the EZA binder on top of the existing EZA (figure 3).

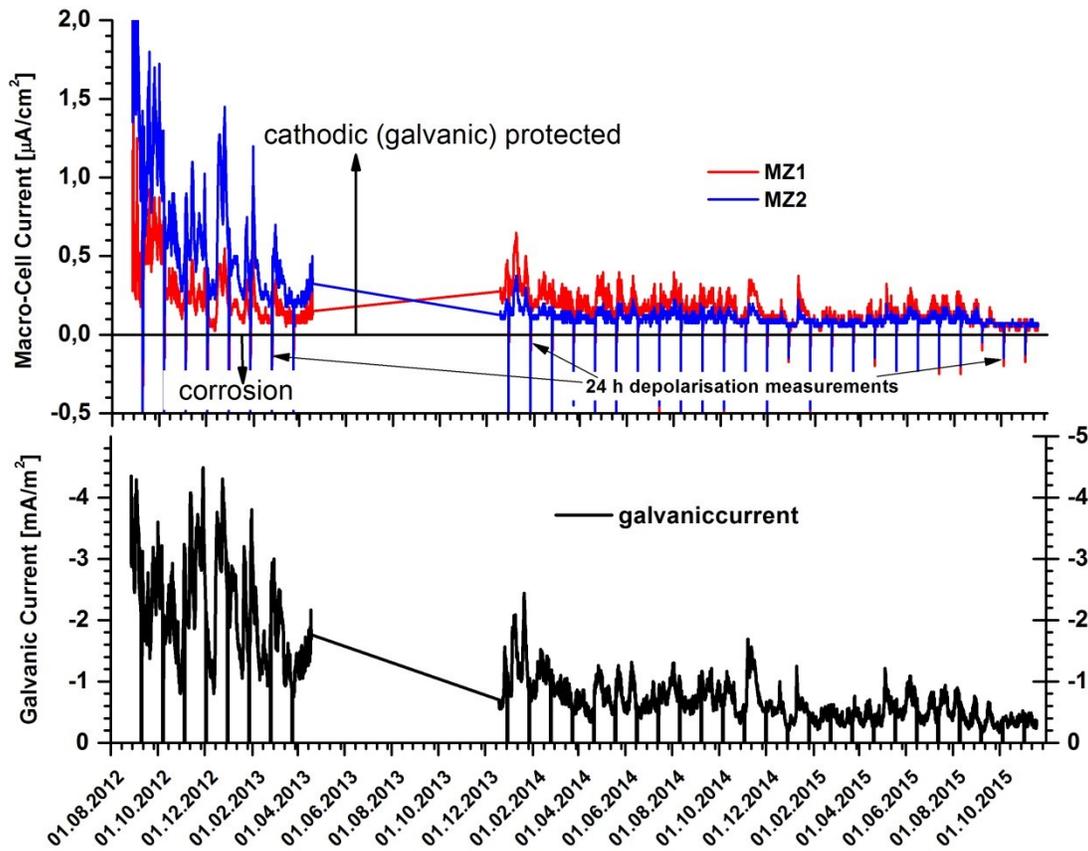
Figure 4. Galvanic Current of the EZA-System in relation to macro-cell currents measured by macro-cell sensors. Data from 1 August 2012 till 19 November 2015

The operating data of the EZA-system over a period of more than six years (1 November 2007 – 19 November 2015) were evaluated and analysed with respect to stability, performance and durability. The galvanic system was put out of operation for about 2 weeks during bridge refurbishment in July 2012 and restarted again on 8 August 2012. Galvanic currents in relation to macro-cell currents measured by macro-cell sensors installed to monitor protection efficiency and eventual corrosion currents demonstrated that the steel reinforcement is fully protected (Figure 4). Temporary corrosion currents were only observed during the 24 hour depolarisation measurements.

The galvanic current of the EZA-system initially high galvanic currents decreased during the first three months continuously and stabilized after about 2 years.

The galvanic current decreased at dry ambient air ($RH < 50\%$) and temperatures below freezing but increased immediately if humidity levels and/or temperature increased again to the values previously measured at the corresponding humidity and/or temperature levels. Furthermore, the numerous wet/dry and freeze/thaw cycles did not affect the long-term performance of the EZA-system. The galvanic zinc anode protects the steel reinforcement reliably and durable from corrosion.

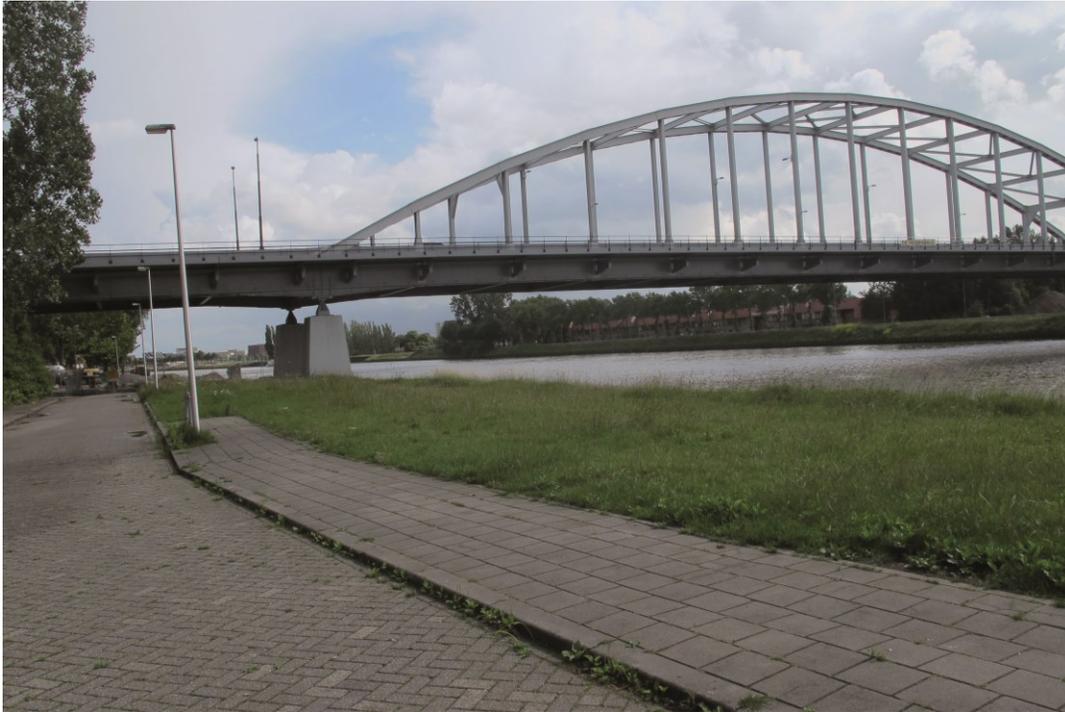
Figure 5. De Meernbrug steel bridge in Utrecht

The De Meernbrug Steel Bridge over the Amsterdam-Rijn canal (figure 5) project in Utrecht, The Netherlands, was realized 2010.

Reinforcement corrosion was initiated due to high levels of penetrated chloride readily available from de-icing salts from the overlying road. Over 1% mass of chloride by mass of cement was present at the rebar level in the damaged areas. Undamaged concrete showed high levels of chloride as well, but were slightly lower as in the damaged areas. During repair works a decision was made to change traditional repair work to cathodic protection.

The three main reasons were: reduction of direct costs due to the fact that traditional repair conforming to EN1504-standards would mean excessive removal of chloride contaminated concrete while cathodic protection would mean limited repair of delaminated and disintegrated spots; reduction of risks for future development of concrete damage on the none repaired locations and reduction of over-all execution time of the work being done. For the protection, some minor surface repairs were performed, after which a zinc mesh with a total amount of 4 kg zinc per m² of concrete surface was applied on a total of 200 m² concrete surface. The EZA system as applied was finalized with an aesthetic coating system based on the Sika Decadex system (figure 6).

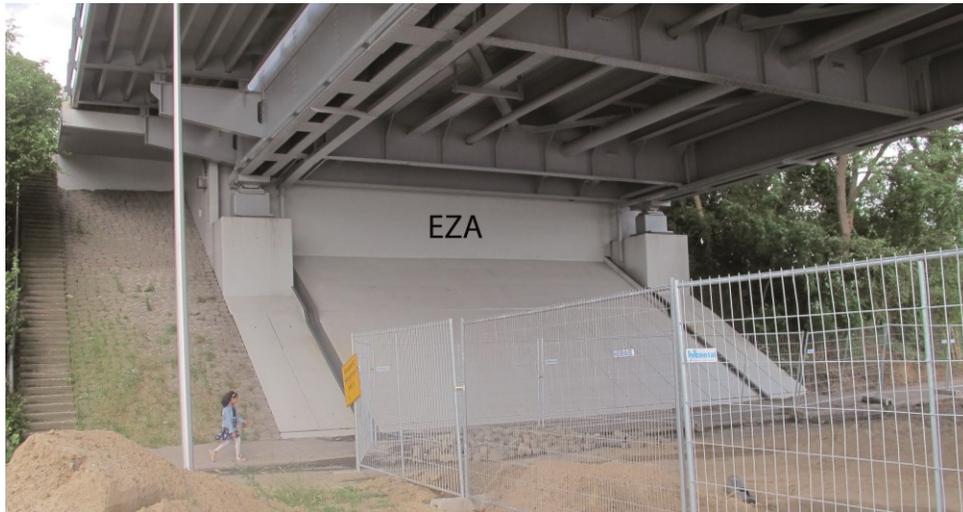
Figure 6. De Meerenbrugg steel bridge with EZA installed on the concrete abutment

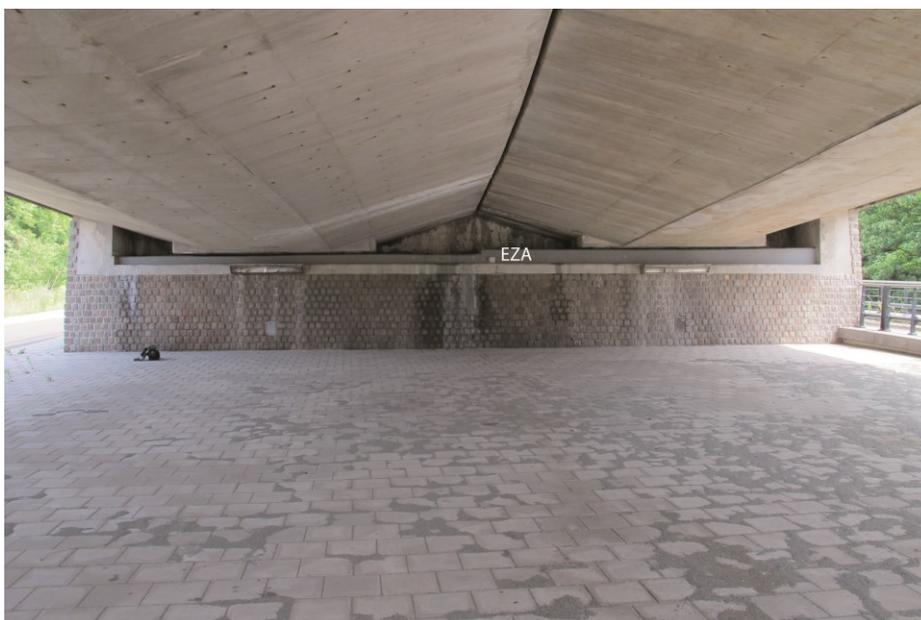
Figure 7. EZA installed on the beams supporting the bearings of the Hubertus viaduct in The Hague

In total 90 m² were covered with zinc mesh with a total of 2 kg per m² of concrete (figure 7 & 8). Considering the low reinforcement density, a lifetime of over 10 years is expected. A total area of 90 m² of concrete was protected on 4 different locations, divided into 5 separate zones.

Table 1. Verification of the effectiveness of the GCP by the EZA by 24 h depolarisation measurements according to ISO EN 12 696. Potential values in mV, measured on beams shown in figure 7.

Date of meas.	Ref. Cell Type	On-potential	Instant-off	4h off	24h off	24h Depol.
30 June 2011	MnO ₂	-547	-457	-386	-288	169
	Ti*	-366	-278	-183	-91	187
30 July 2013	MnO ₂	-551	-499	-404	-245	254
	Ti*	-356	-314	-237	-70	244
25 May 2016	MnO ₂	-486	-402	-367	-250	152
	Ti*	-325	-291	-244	-77	221

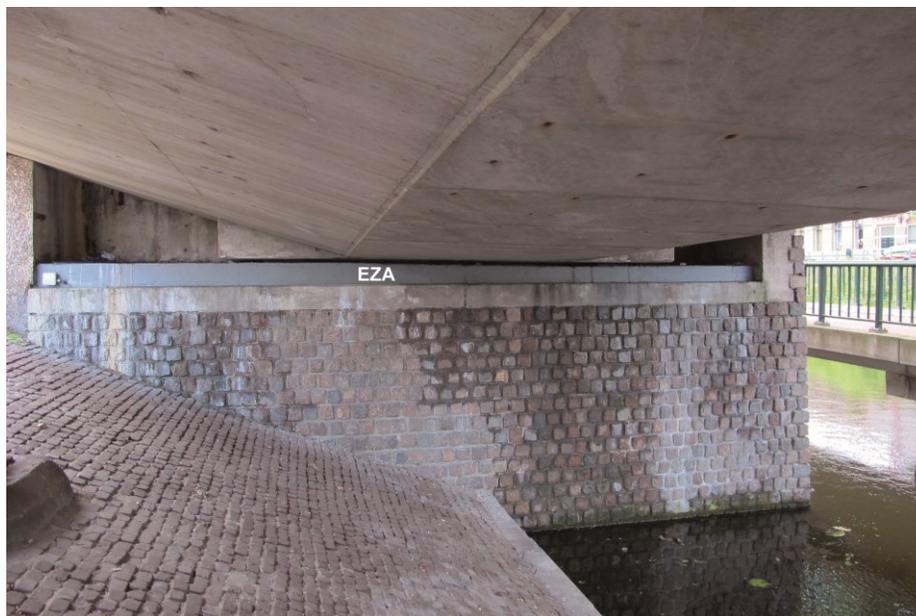
Figure 8. EZA installed on the beams supporting the bearings of the Hubertus viaduct in The Hague

Table 2. Verification of the effectiveness of the GCP by the EZA by 24 h depolarisation measurements according to ISO EN 12 696. Potential values in mV, measured on beams shown in figure 8.

Date of meas.	Ref. Cell Type	On-potential	Instant-off	4h off	24h off	24h Depol.
30 July 2013	MnO ₂	-559	-507	-466	-327	180
	Ti*	-288	-245	-194	-115	130
25 May 2016	MnO ₂	-430	-416	-353	-302	114
	Ti*	-279	-256	-185	-118	138

The results show that over a period of more than 8 years, the 24 h depolarization values are far above 100 mV required by ISO EN 12696 for reliable corrosion protection.

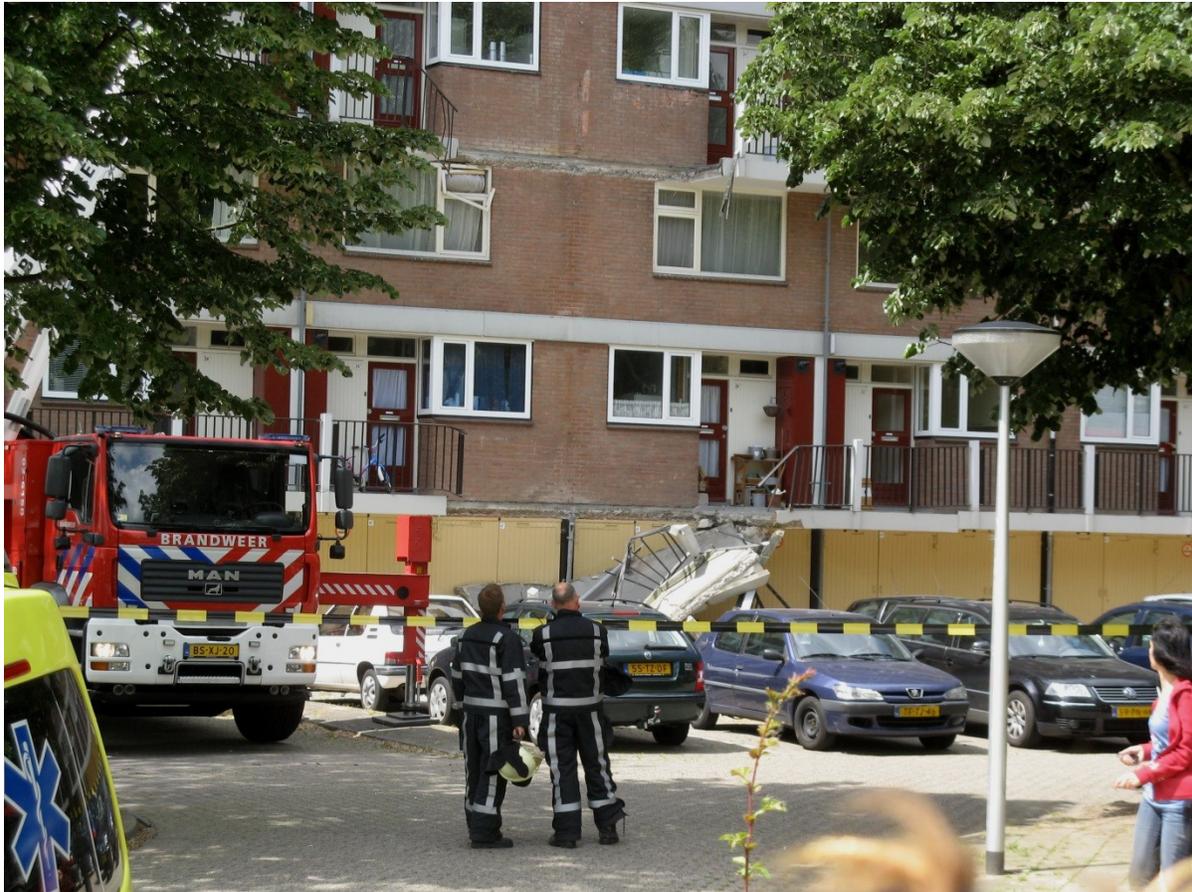
Figure 9: Failing cantilever slabs (The Netherlands, 2011)

After evaluating a large number of reports on these slabs, the Dutch Centre for Building Research and Recommendations (SBRCUR), concluded that 40% of all cantilevered construction were unsafe, of which 25% was caused by reinforcement corrosion. And of the other 60% considered safe at the moment, it was concluded that in 92% of these plates corrosion of the reinforcing steel has to be prevented. Obviously cathodic protection of the reinforcing steel would be a safe method in order to avoid steel corrosion and maintain structural integrity. In the period of 2014-2016 several projects were conducted providing just that, by means of applying an anode in form of a zinc mesh embedded in a proprietary matrix (figure 10 – 12, next page). Typically, these plates (or sections) are about 5 by 1,2 meters and are covered with the anode system on the topside. After application the anode system can be finished by traditional flooring systems of different kinds, shapes and colors. The projects have been realized by Vogel Cathodic Protection BV, a subsidiary of Joh. Mourik & Co. Holding B.V.

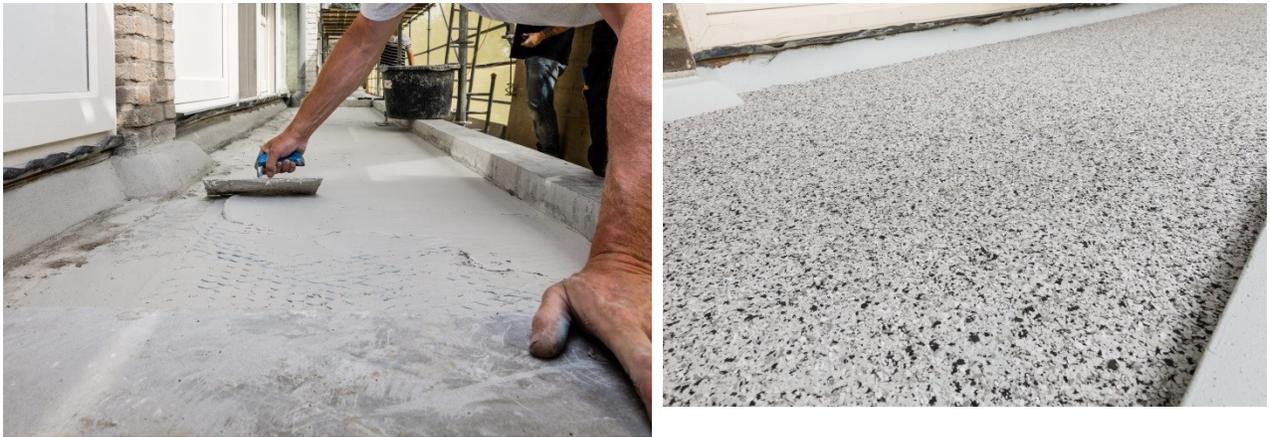
Figure 10: Installation of the EZA system on balconies (left), finished surface (right), Rotterdam 2014

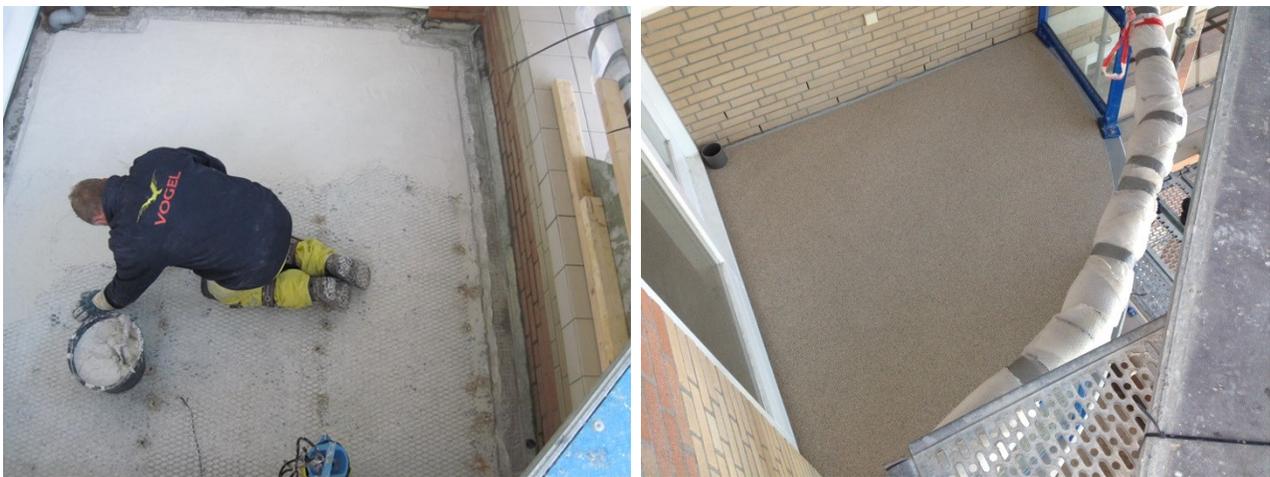
Figure 11: Installation of the EZA system on balconies (left), finished surface (right), Egmond aan zee: 2014

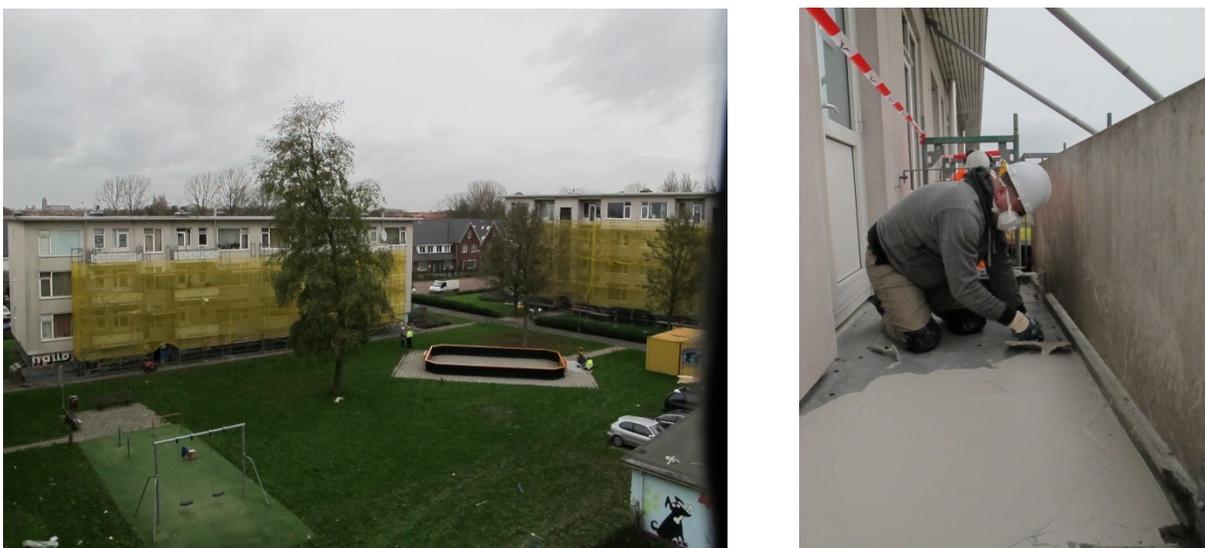
Figure 12: Installation of the EZA system on a total of 400 balconies of apartment buildings (left), finished balcony surface (right), Dordrecht 2015

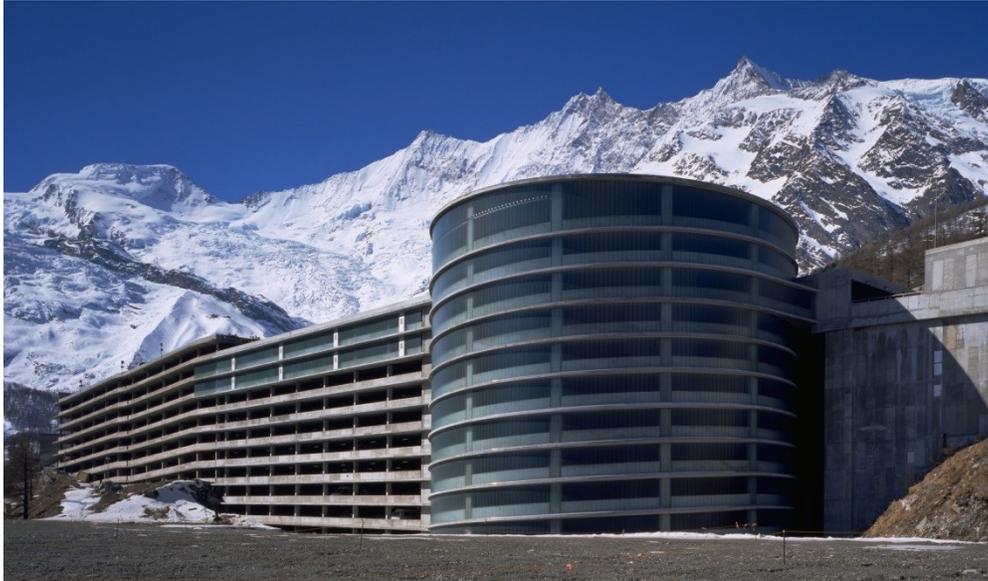
Figure 9. Central parking deck in Saas Fee, Switzerland

The parking garage in Saas Fee is designed to take in all cars of tourists and inhabitants of Saas Fee – the village of Saas Fee is free of fuel powered vehicles. The parking deck was erected 1979/80 and extended with a new section 1980/81, offering 2900 parking lots (figure 9).

The concrete overlay of the decks are impregnated with chlorides ranging from 0,5 – 3,0 wt./wt% cement near the loose steel reinforcement. The decks are reinforced with unbonded post-tensioned tendons. Conventional techniques would require the removal of with chloride contaminated concrete, coating of the steel reinforcement and refurbishment with repair mortar or concrete. This procedure would be highly delicate with regard to the unbonded tendons in the parking deck – damage to these tendons has to be avoided under any circumstances.

With regard to the pre-stressed tendons and the risk of CP induced hydrogen embrittlement, galvanic corrosion protection offers a safe and reliable remediation technique. In July 2011, on a parking booth, the EZA system was installed on 30 m² concrete sur-face (figure 10). The EZA system has been coated with a tough elastic, static crack-bridging waterproofing and wearing surface layer of broadcast total solid epoxy Sikafloor-390, covered by a high abrasion resistant sealcoat of total solid epoxy Sikafloor-354.

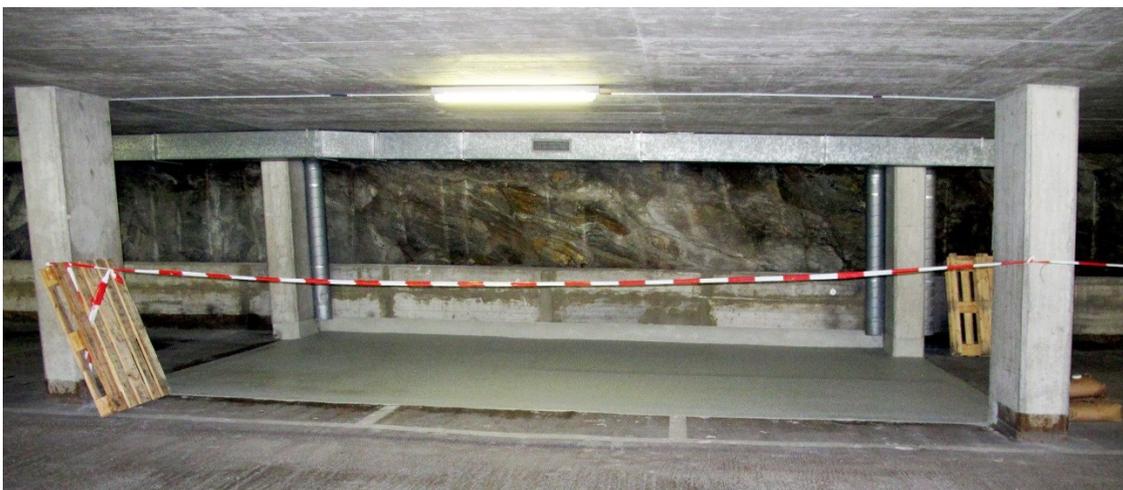
Figure 10. EZA-installation in one parking booth

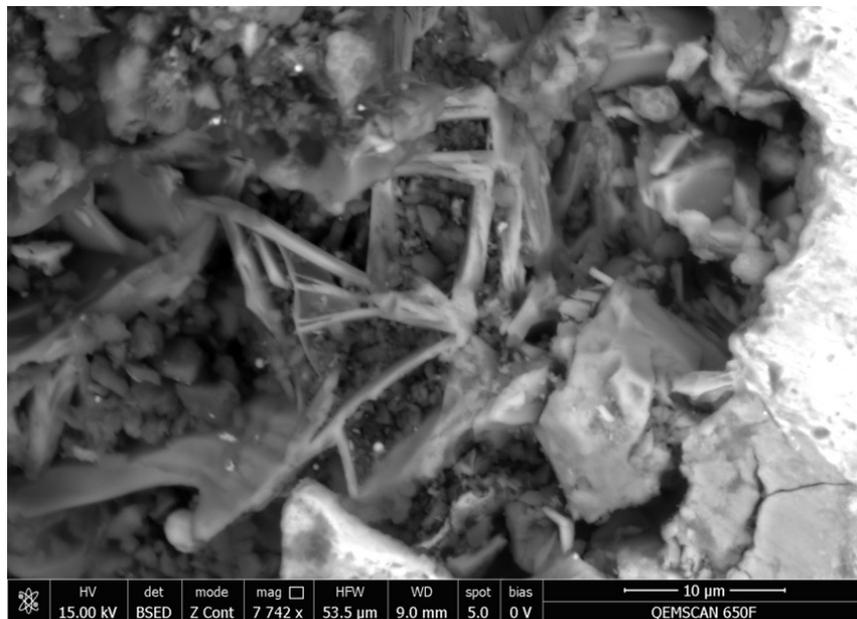
Figure 11. Zinc-hydroxychloride (Simonkolleite) precipitate near zinc anode

An important aspect with regard to the service time of zinc based galvanic anodes and the durability of corrosion protection of steel in concrete is the “galvanic chloride extraction”. Migration leads to an accumulation of anions, especially of chloride ions, at the anode and a depletion of chlorides near the steel rebar surface. Migration is counterbalanced by diffusion. Once the rate of diffusion of chloride ions accumulated at the anode into the concrete cover is equal to the rate of migration towards the anode then no net movement of chloride ions and therefore no further chloride extraction will occur. Differing from all other anode systems used for CP or for chloride extraction, chloride ions are potentially chemically immobilized near the zinc anode by reacting with anodically formed zinc hydroxide as zinc-hydroxychlorides - zinc-hydroxychlorides are nearly insoluble in water (Clever et al. 1992) as shown in figure 11.

This “one-way” transport of chlorides towards the galvanic zinc anode may result in an efficient chloride extraction of chlorides from the concrete cover and subsequently, leads to the repassivation of the steel reinforcement confirmed by rest potential and macro-cell current measurements. It was proven to be highly efficient in the TAS-EZA system in laboratory and is currently evaluated in EZA field installations. One may expect that chloride is efficiently removed from the concrete cover at the end of the service time of the EZA provided that the EZA is coated with an elastic membrane impermeable to liquid water.
